AIRCRAFT ACCIDENT REPORT

TRANS WORLD AIRLINES, INC.

BOEING 727-231, N54328

REPORT NUMBER: NTSB-AAR-75-16

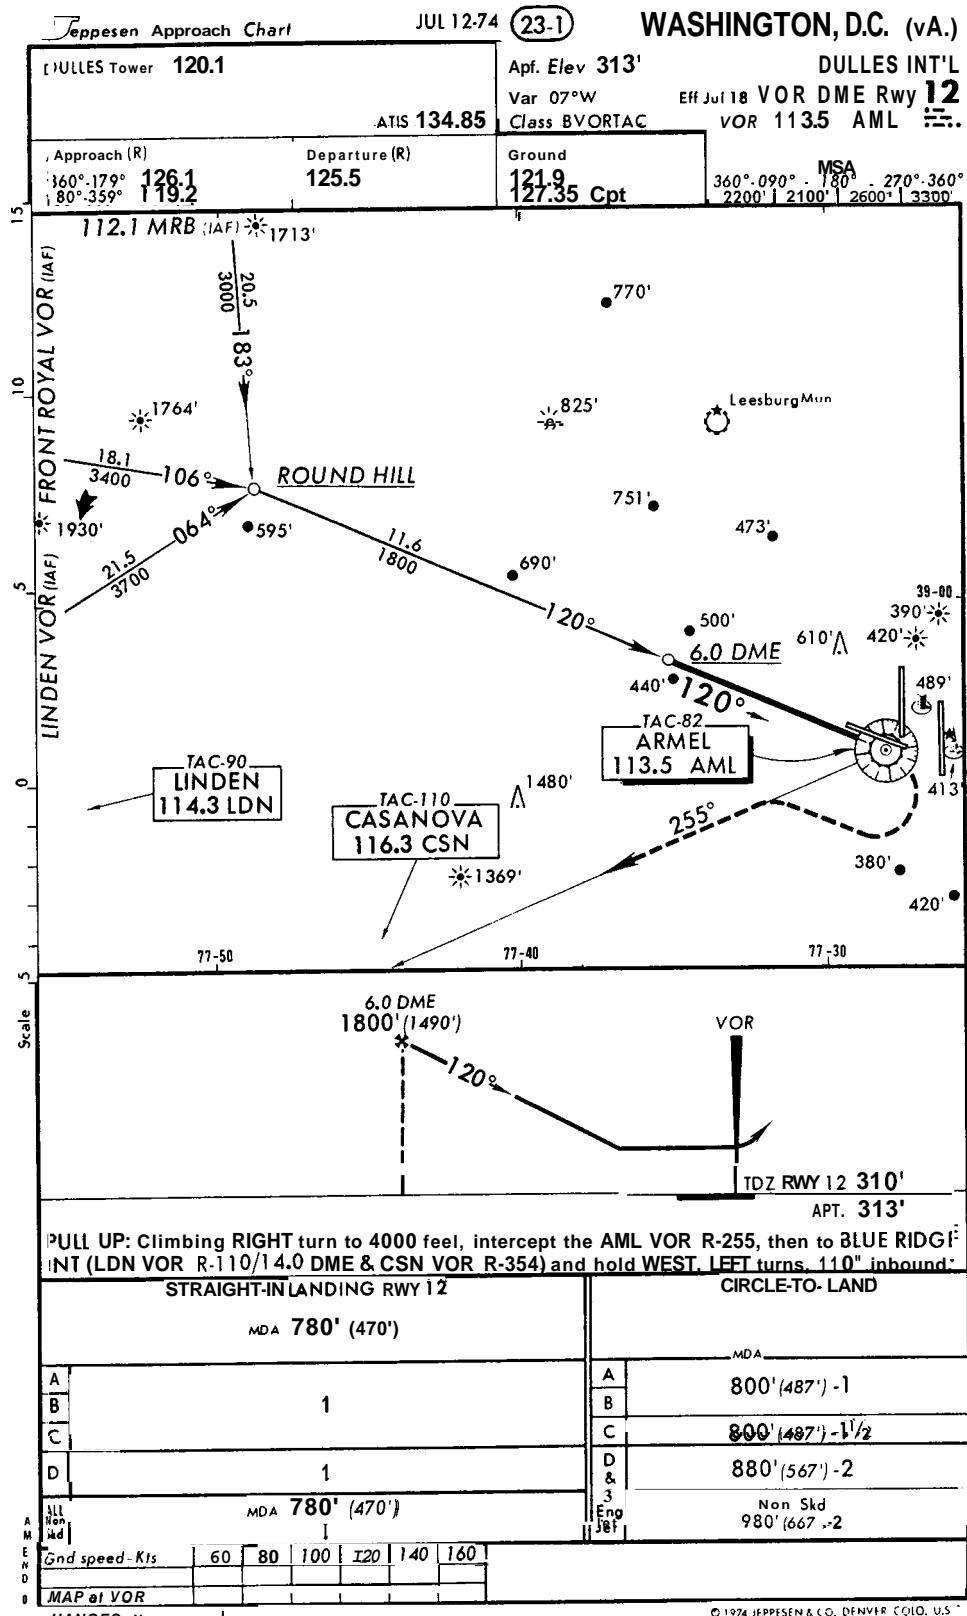
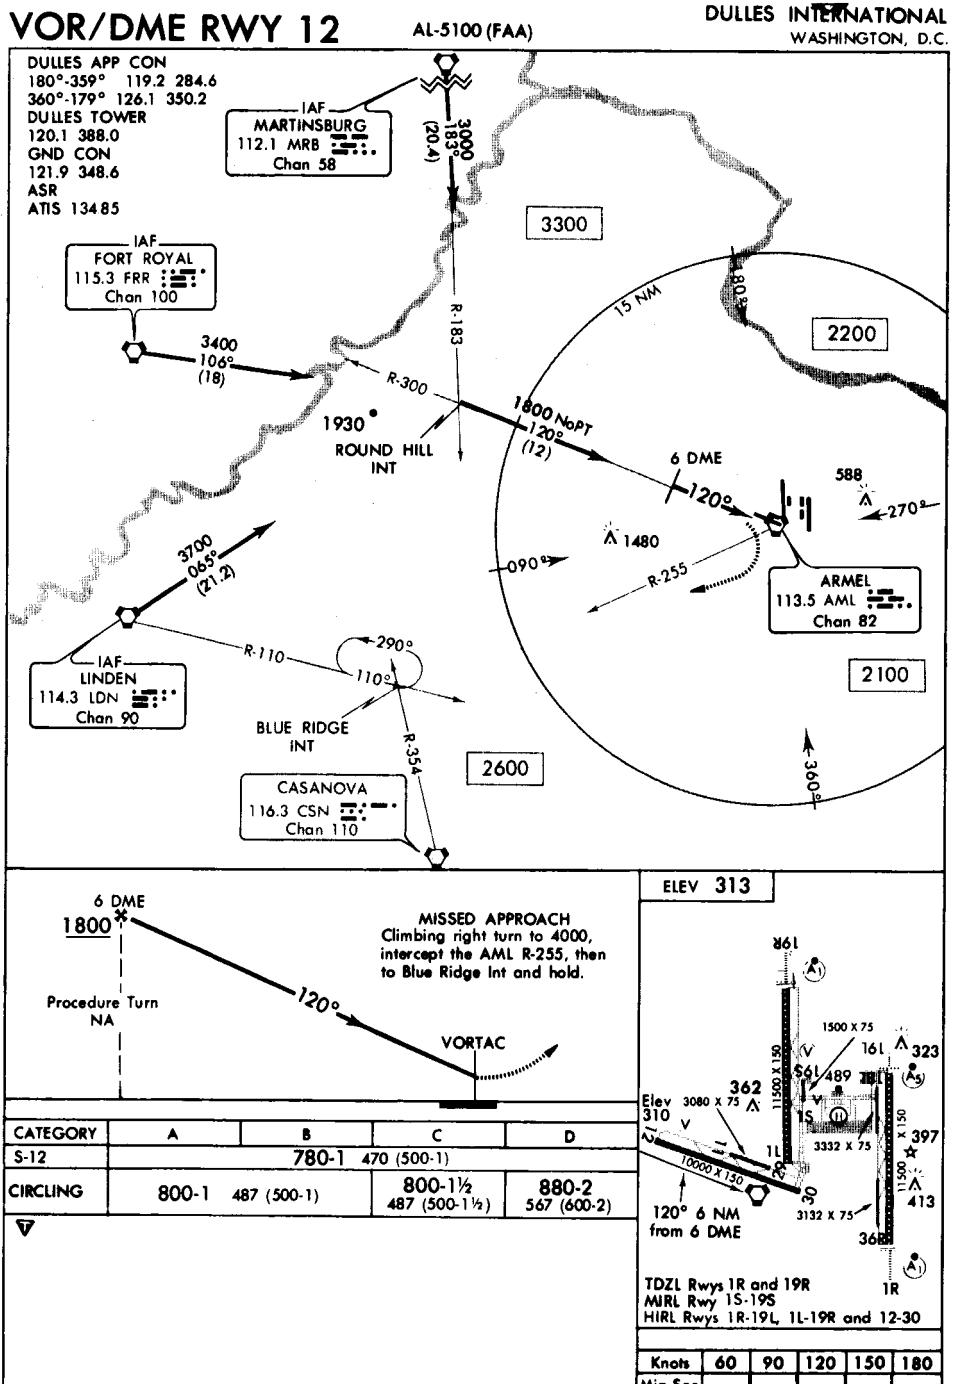
APPENDIX D

(3) Inadequate depiction of altitude restrictions on the profile view of the approach chart for the VOR/DME approach to runway 12 at Dulles International Airport.

The information available to the pilot, including the approach chart, should have alerted the crew that an unrestricted descent would be unsafe. It does appear to the Board that there was a deficiency in the chart. This particular approach chart depicted the profile view from the final approach fix to the airport. It did not depict the intermediate fix, Round Hill, with its associated minimum altitudes. This information was available from the plan view of the chart, but it appears that the crew gave their primary attention to the profile. If this was the

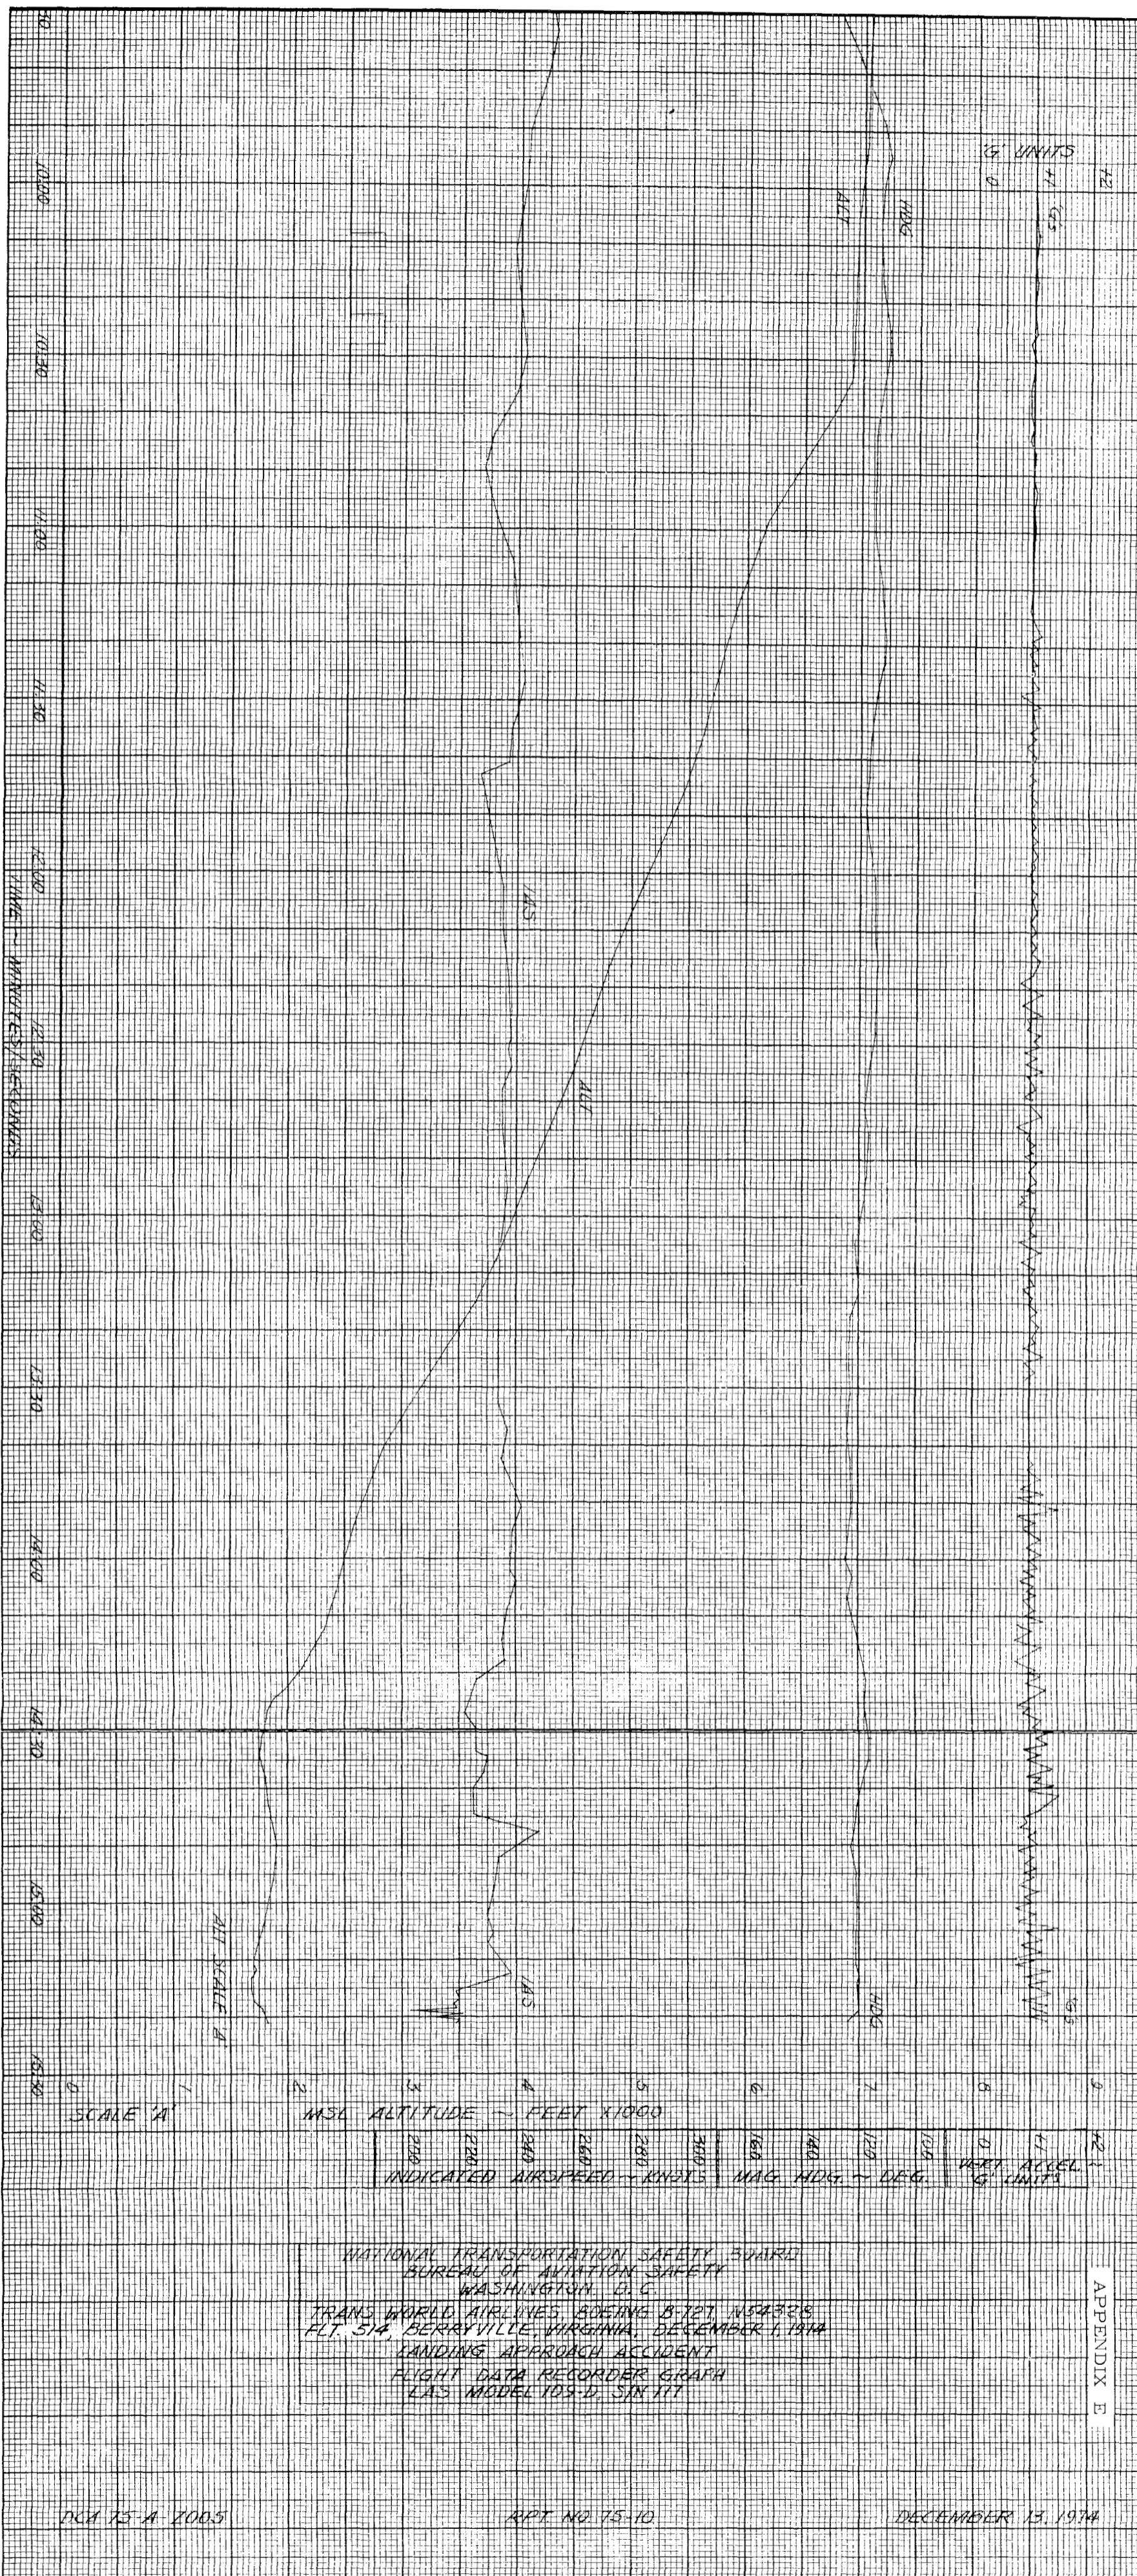
The flight data recorder parameter traces were clearly recorded. There were no recorder malfunctions. A readout was made of the last 15 minutes 25 seconds of the flight. There was a small gap in the vertical acceleration trace shown on the data graph at time 13 minutes 30 seconds because of foil damage which obliterated the trace. (See Appendix E.)
