**“Reduce Continuing CFIT Accidents by  
Training Constant Descent Final Approaches  
Using Distance-Altitude Tables to Follow the  
Glideslope Angle to an Accuracy of 30ft”**

*Including LOC-DME Accident 14 Aug 13  
of UPS A300-600F into Birmingham, Alabama*

**Hugh DIBLEY** FRAeS, FRIN, CMILT

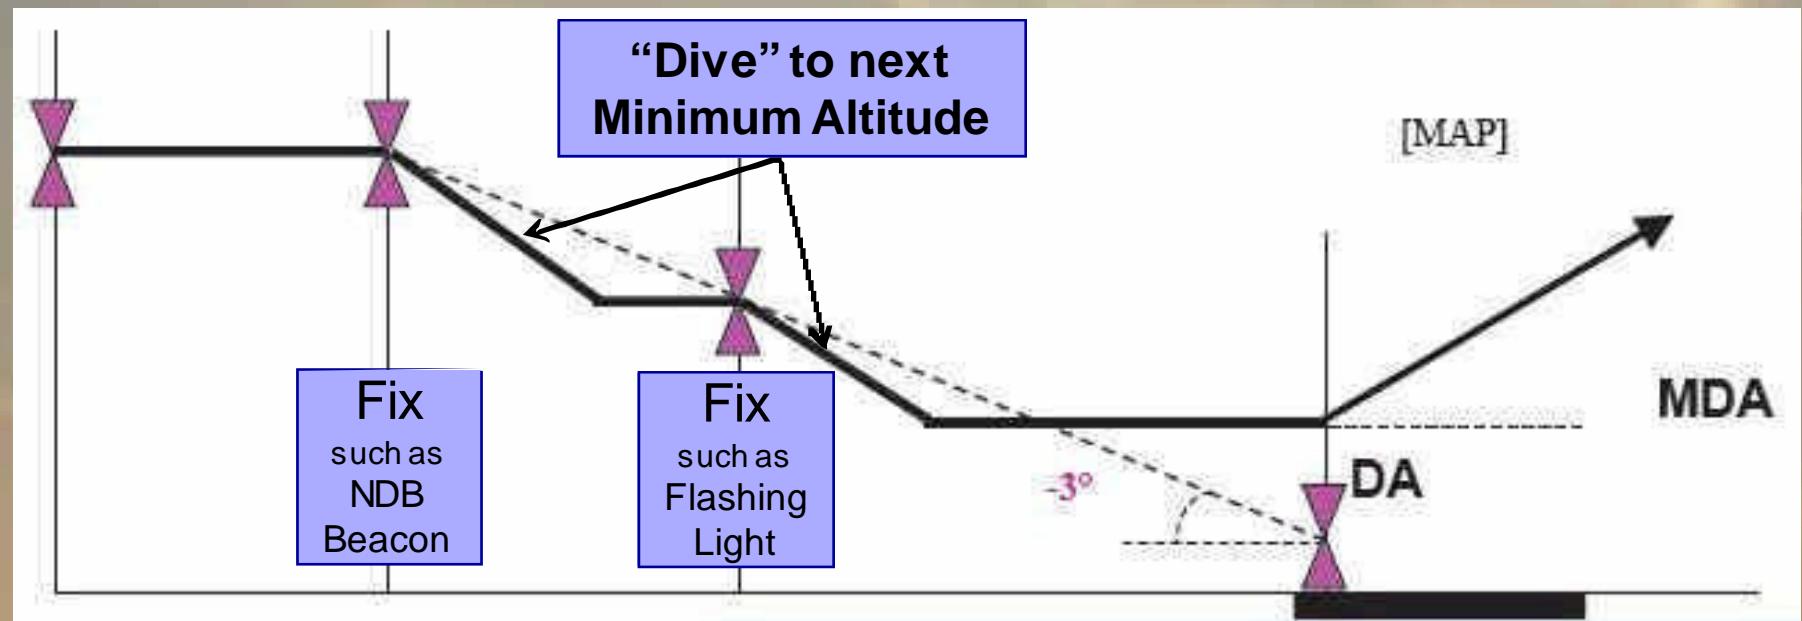
# Before DME / reliable distance information NPAs Had to be Step Down or “Dive and Drive”

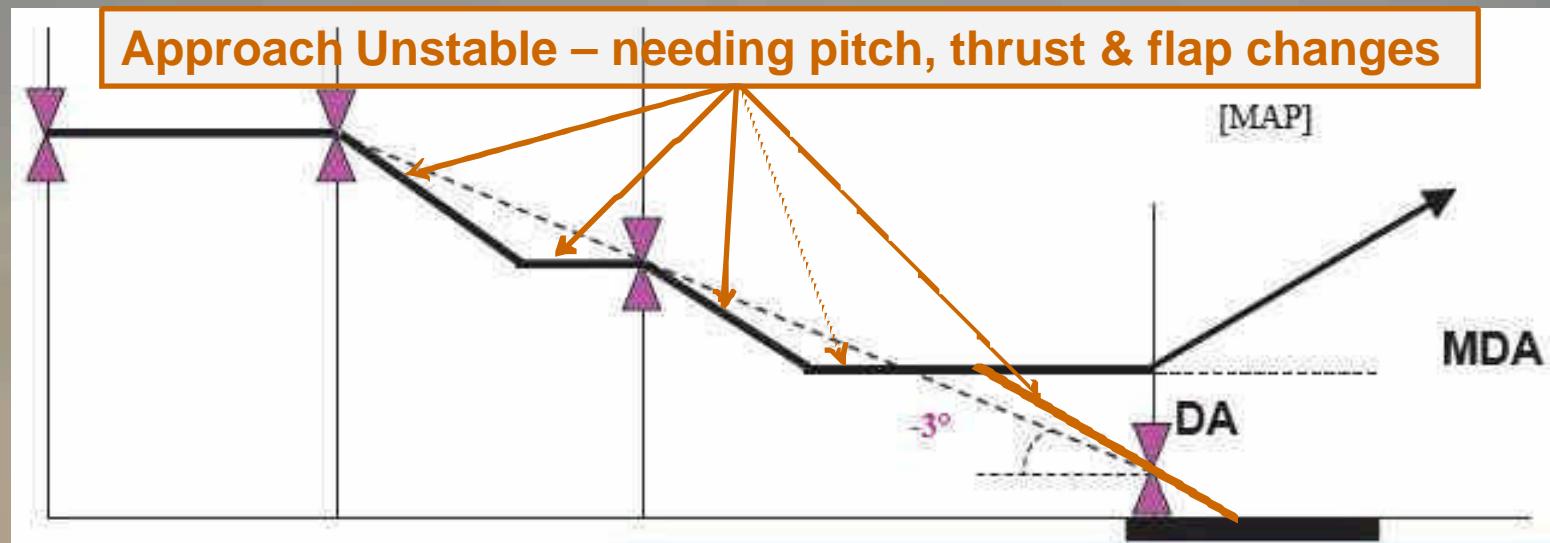
## Unstable profile

Unstable profile leading to unstable approaches

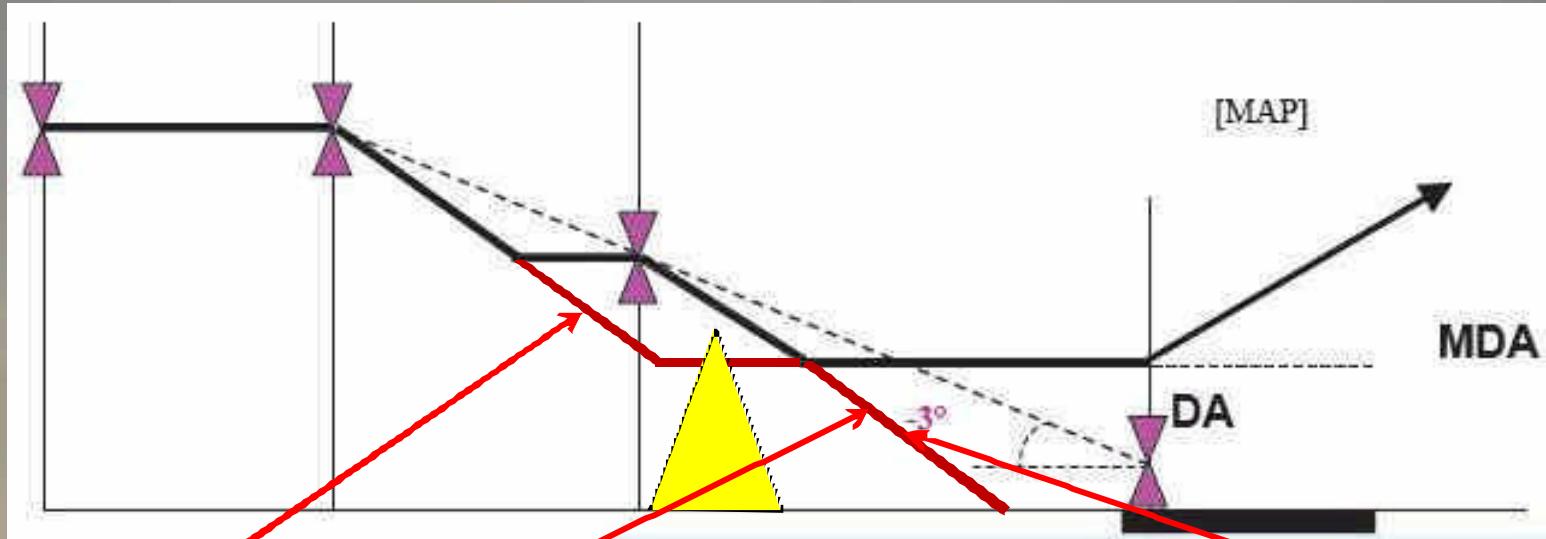
Missed step or late stabilisation causes accidents

Crew missed a step, stabilised late, or failed to monitor DME-Altitude glideslope

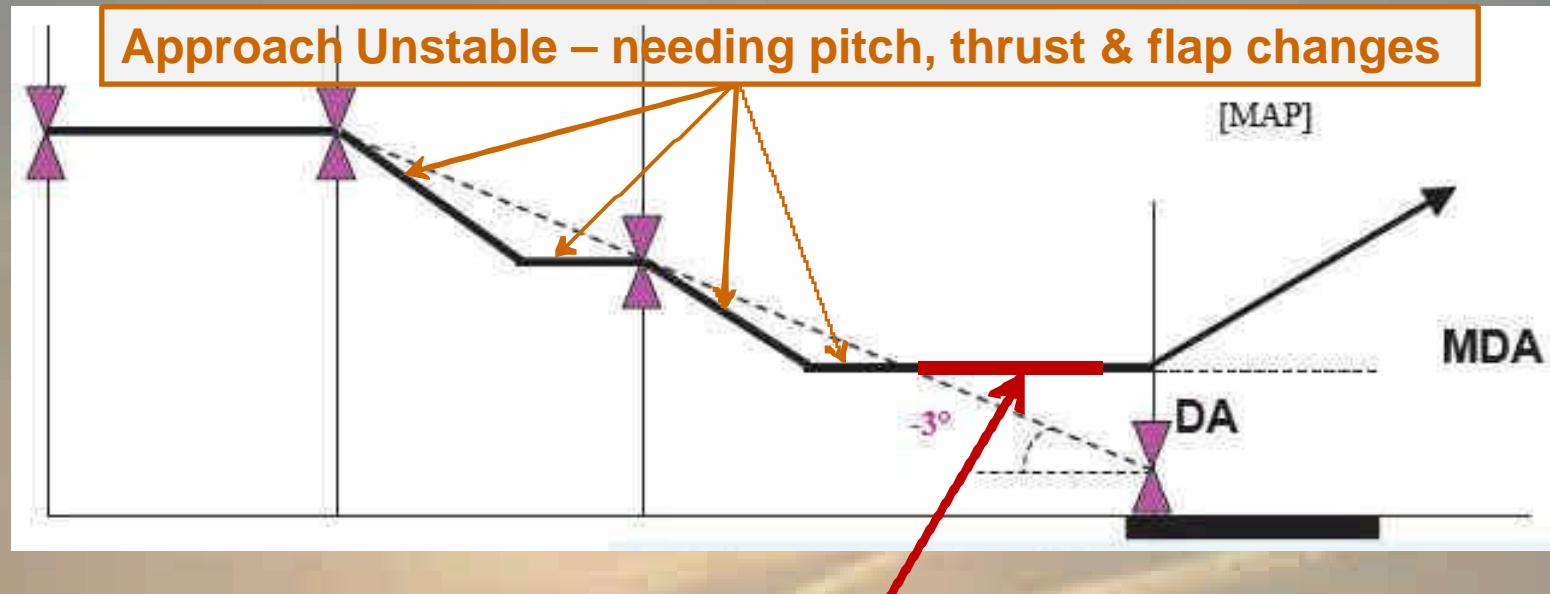
Chance of hard landing or runway over-run

Flying level pitched up at MDA obtaining visual reference causes late “dive” at the runway with hard or deep landing and runway over-run.

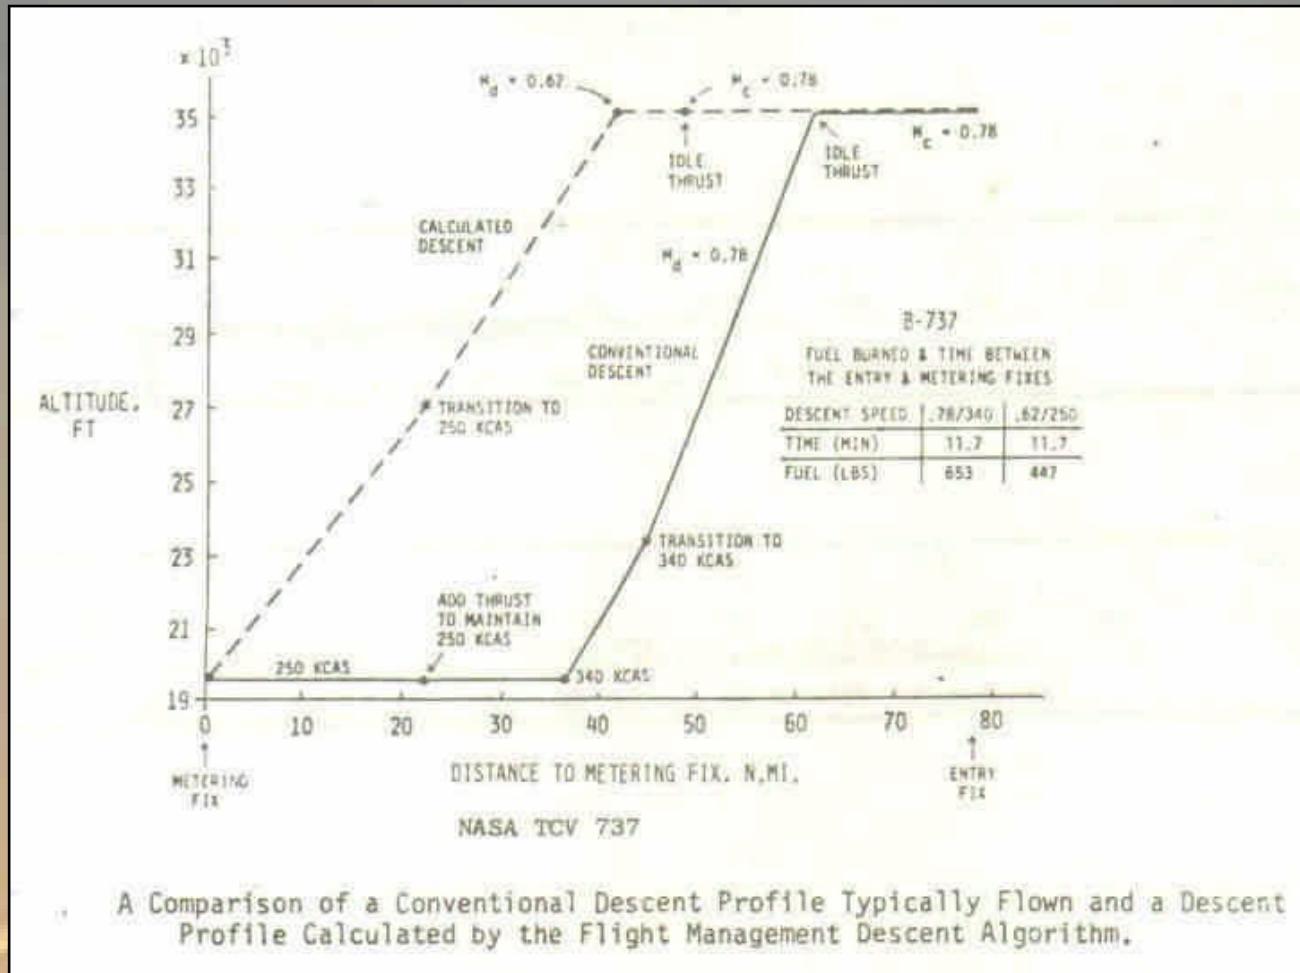
NASA found crews descended early rather than on optimum profile

Mentally computed descent profiles are usually not optimum

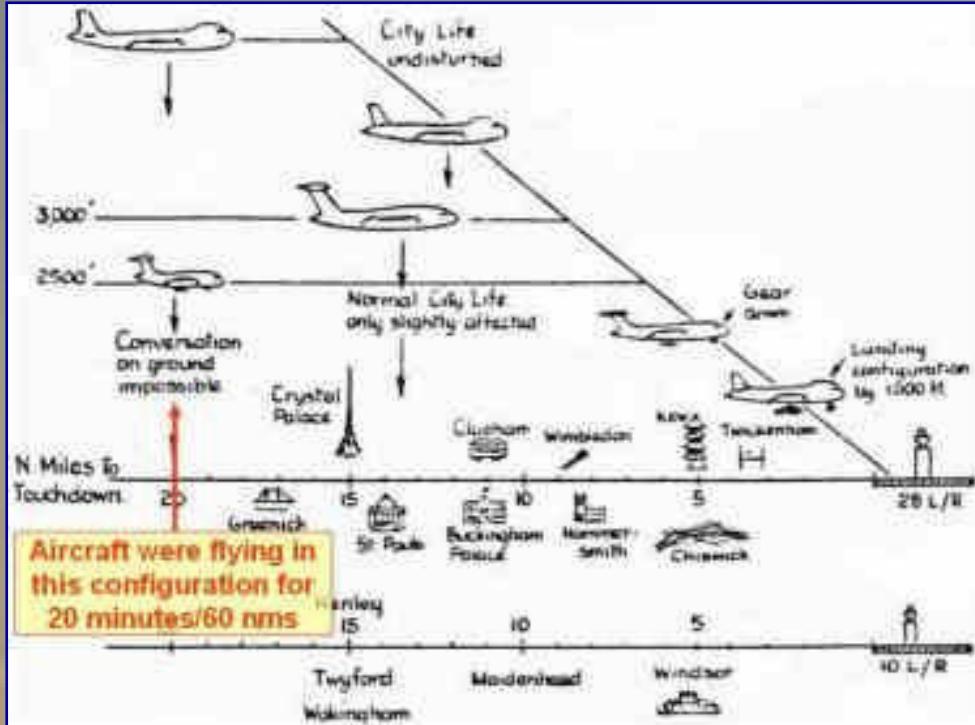
Fuel efficient quiet Constant Descent Approaches from the holding fix altitude were introduced into London Heathrow in 1975 using ATC distance to run & DME distance from the runway for guidance.

*Besides minimising fuel burn and noise, following this profile improves safety by keeping the aircraft well clear of the ground into nearly all airfields.*

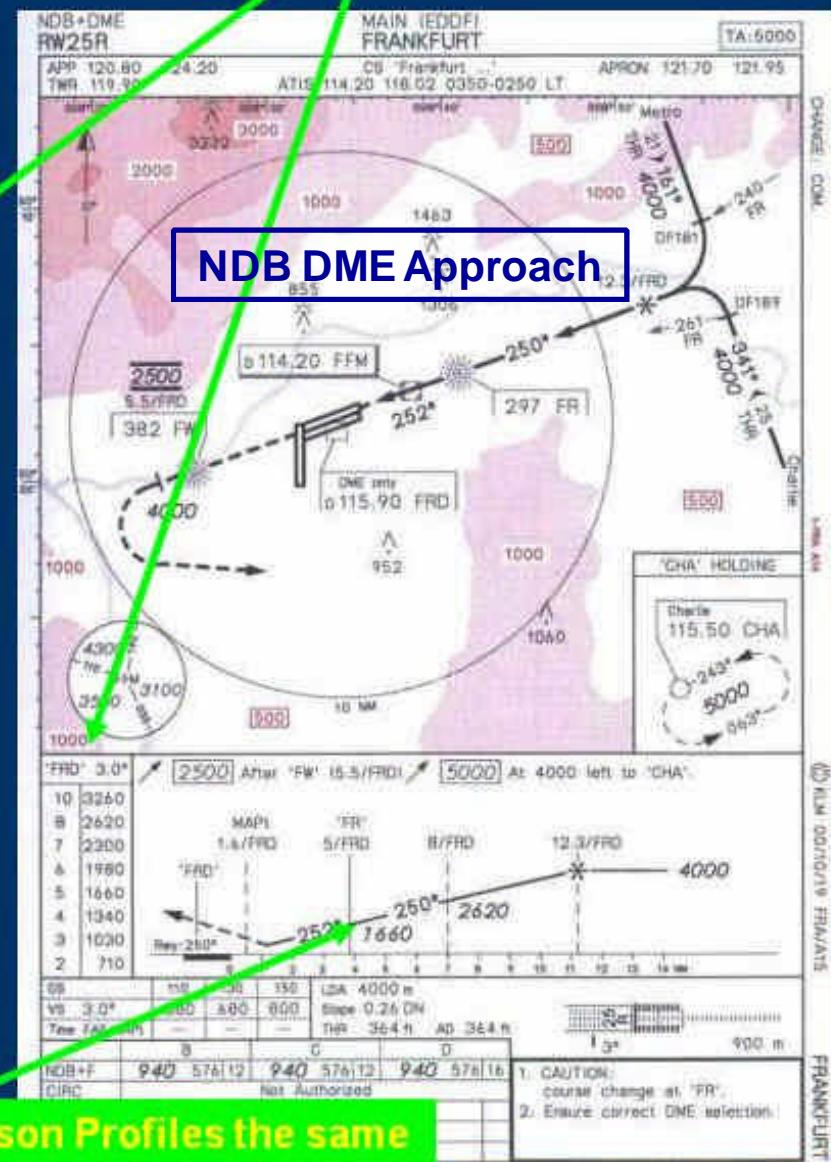
# KLM ILS and NDB Approach Charts with DME-Altitude Tables

**Precision and Non Precision Profiles the same**

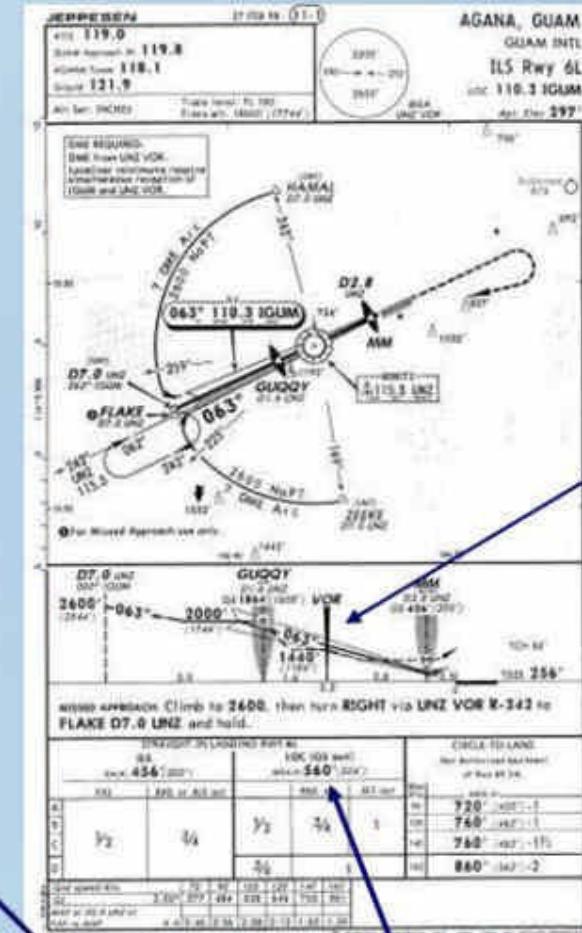
LOC GS Out Approach but DME on VOR 3.3 nm short of r/w

Step down / Dive & Drive Approach

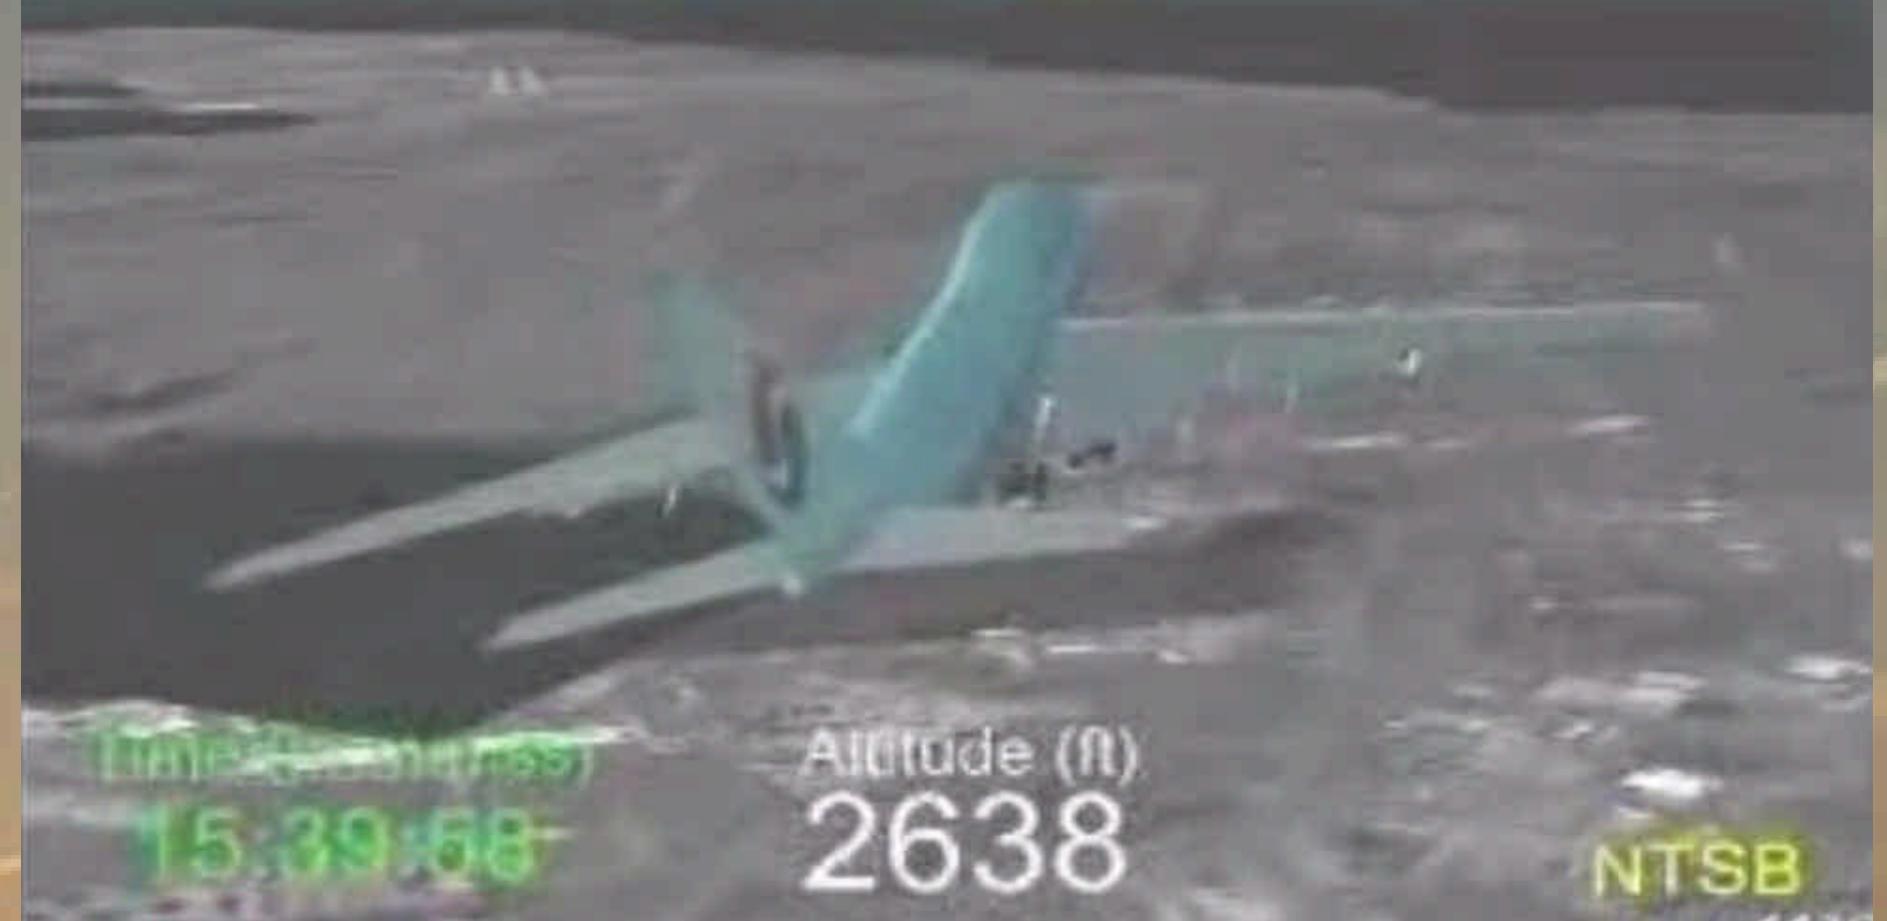
# KAL B747-300 CFIT Accident into Guam 6 Aug 1997

**With the Glide Slope transmitter out of service, a radio signal was clearing the GS Fail flag giving an indication of on Glide Slope to the pilots.**

**The captain asks if the glide slope is working and the FO confirms it is not.**

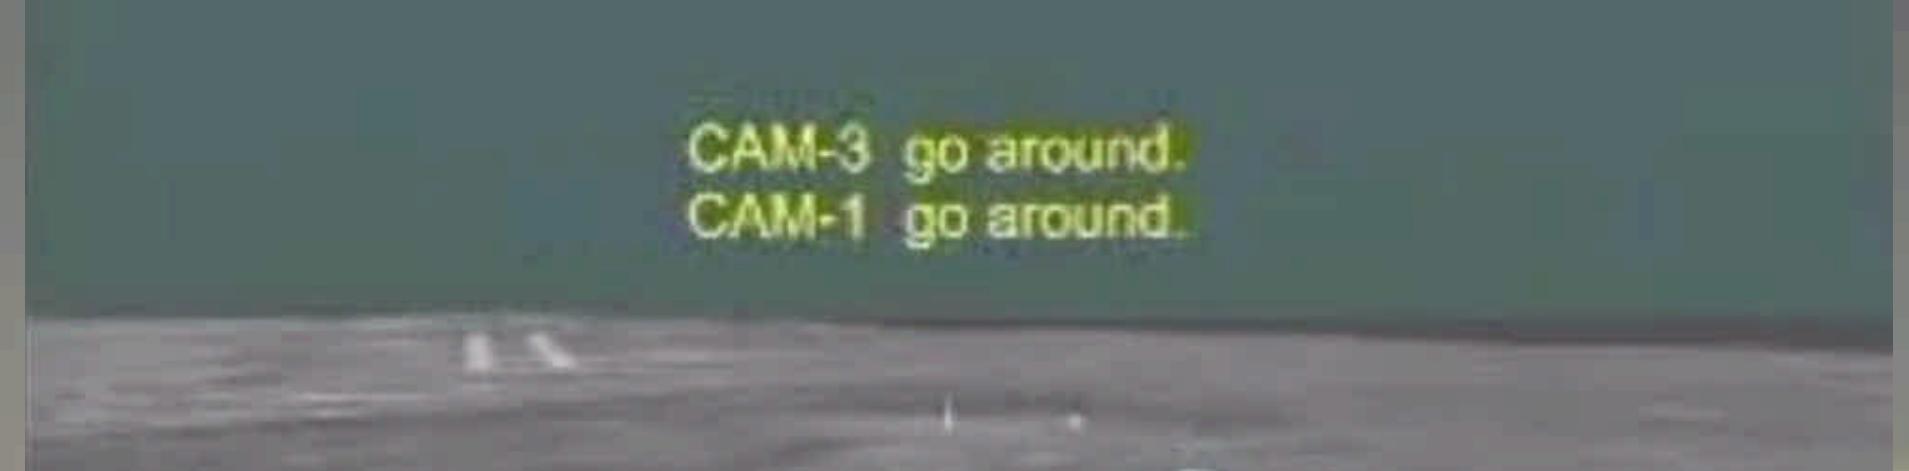
# KAL B747-300 CFIT Accident into Guam 6 Aug 1997

CAM-3 go around.  
CAM-1 go around.

**The captain started a Go Around at 692ft amsl, 130ft above the 560ft MDA, but did not pitch up quickly enough and the aircraft hit the hill of 660ft close to the VOR site.**

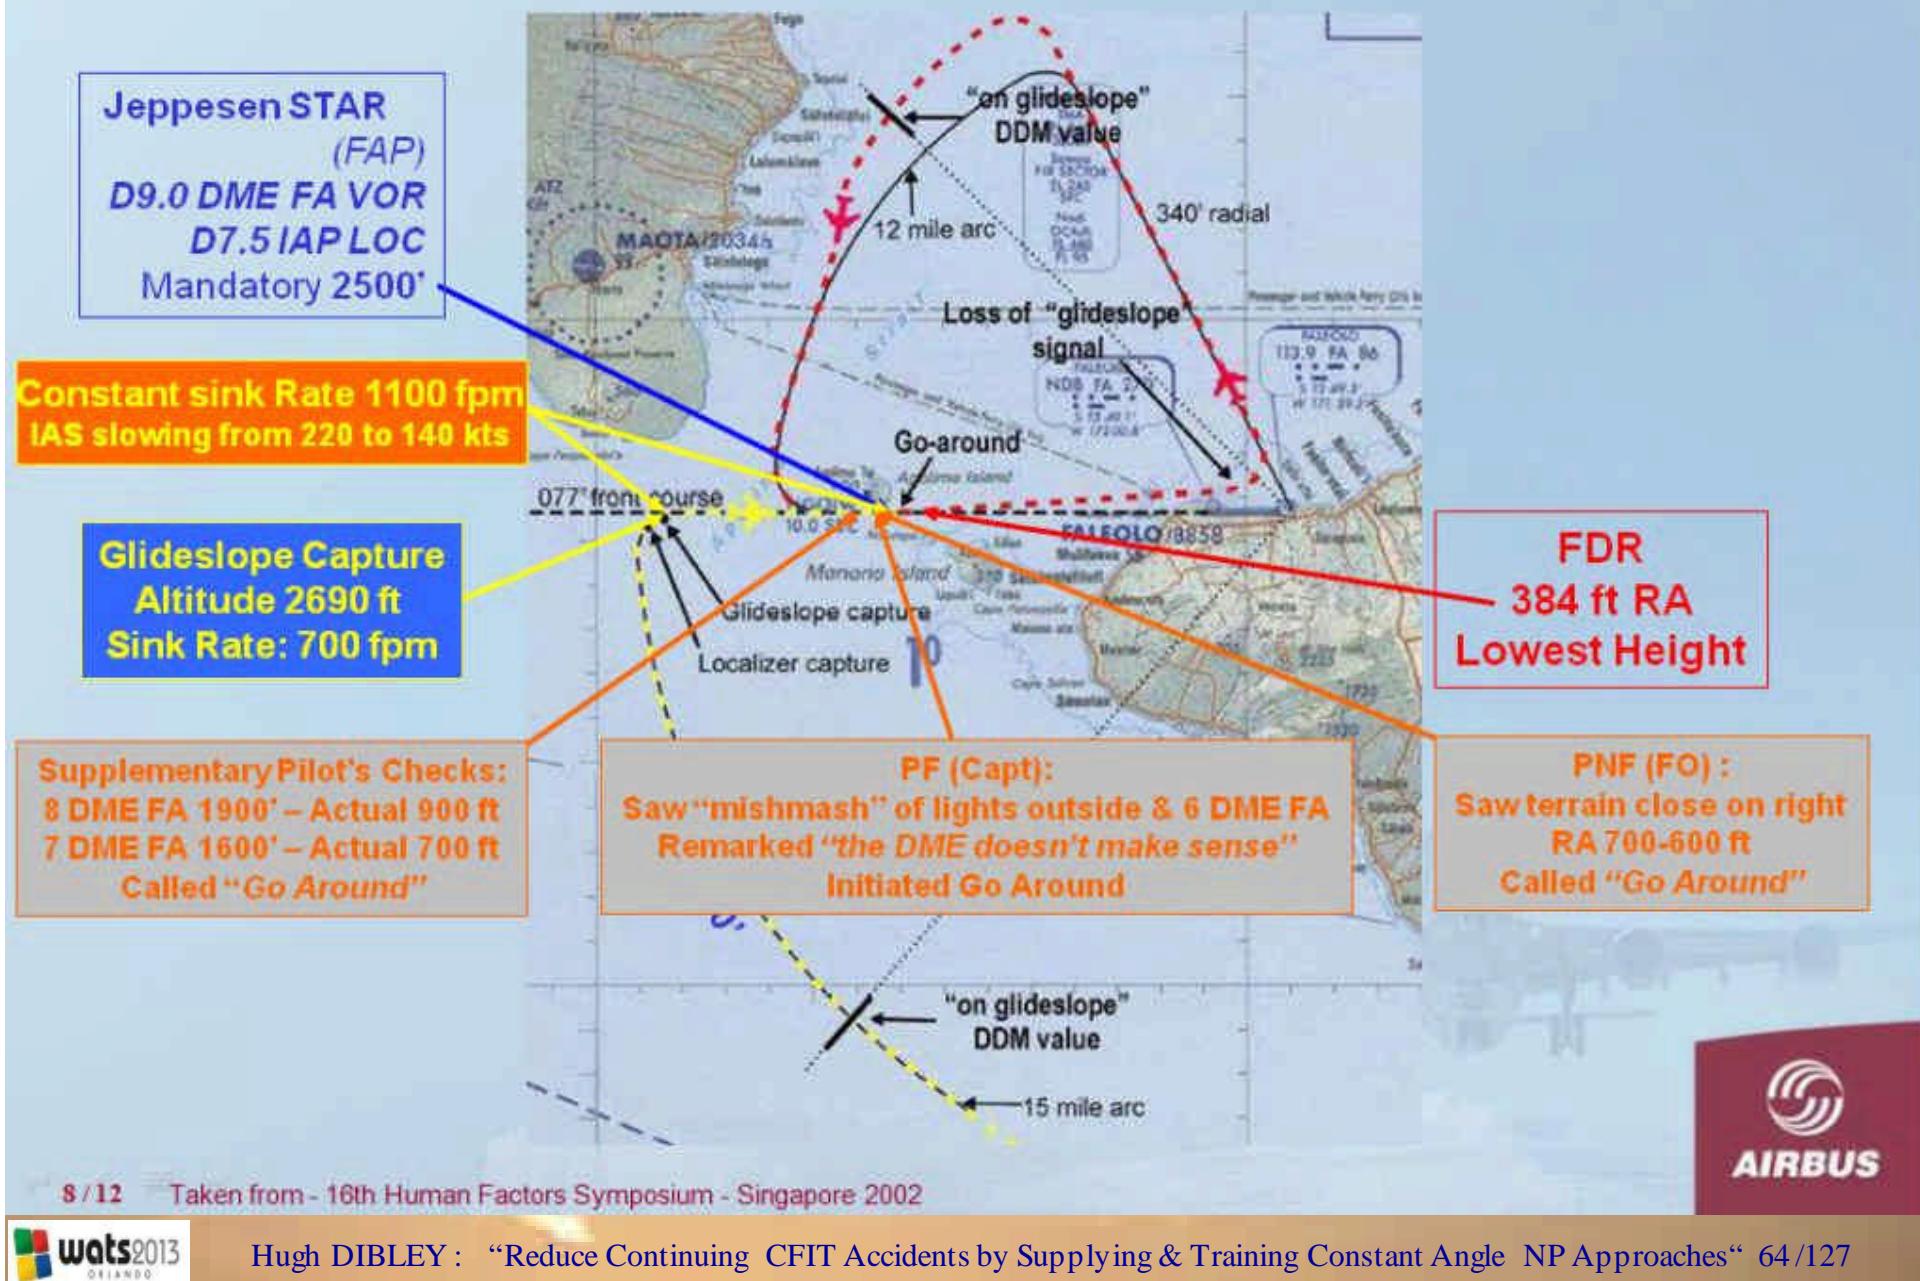
# ANZ Erroneous GS Capture Resolved by DME-Altitude Checks

Jeppesen STAR  
(FAP)  
D9.0 DME FA VOR  
D7.5 IAP LOC  
Mandatory 2500'

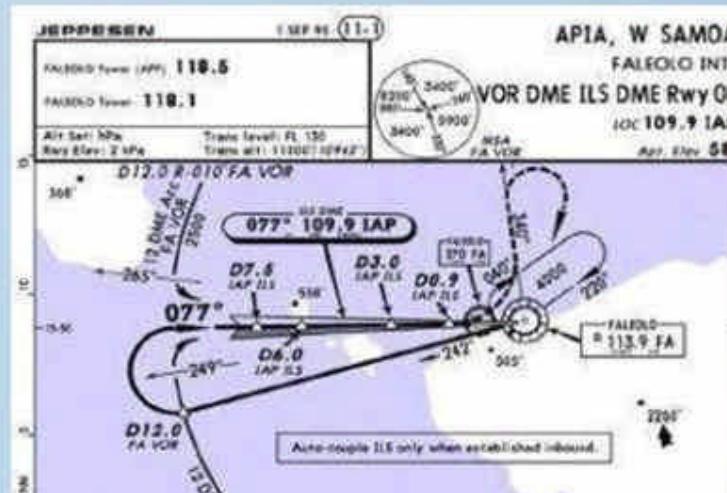
Jeppesen  
APIA, W SAMOA  
VOR DME ILS DME Rwy 08  
Chart In Use

## Chart in use had DME-Altitude table

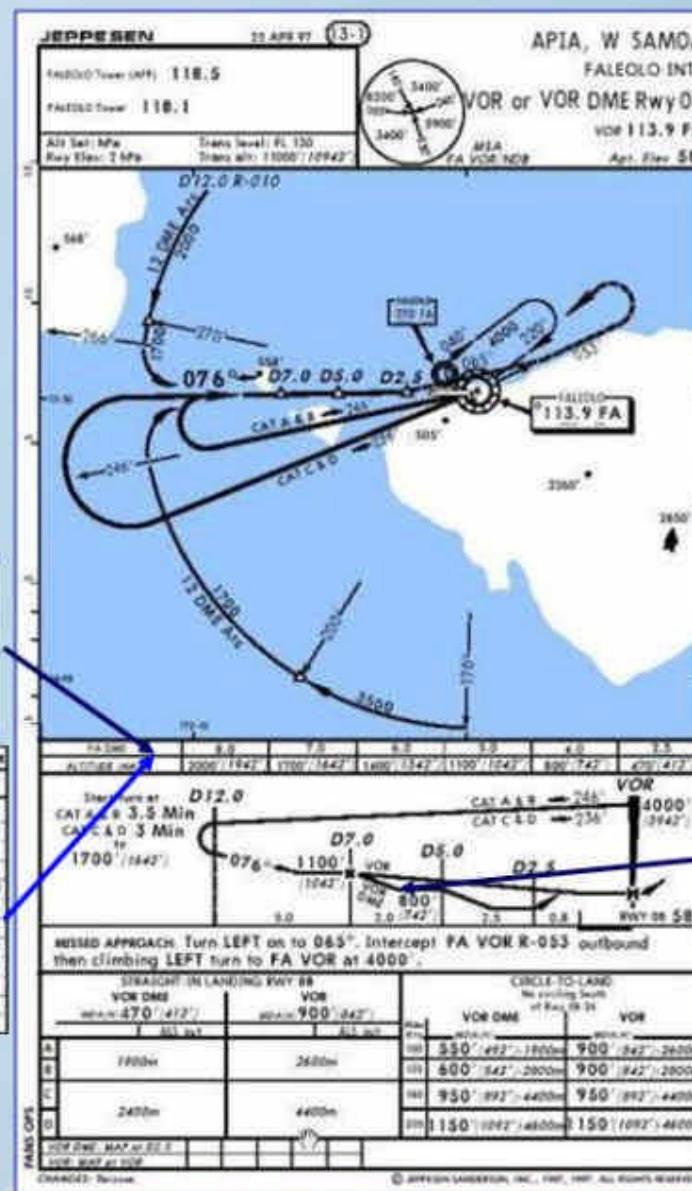
Jeppesen DME-Altitude  
VOR Constant Angle  
Profile

Jeppesen DME-ALT Table						
APW VOR DME 08						
Gradient	2.8°	3.0°	3.5°	4.0°	4.5°	5.0°
120 kts	140 kts	160 kts				
300 fpm	350 fpm	400 fpm				
<b>D KA</b>	Alt QNH	(HAT)				
<b>D -9.0</b>	1400'	(1342')				
<b>D -8.0</b>	1250'	(1192')				
<b>D -7.0</b>	1100'	(1042')				
<b>D -6.0</b>	950'	(892')				
<b>D -5.0</b>	800'	(742')				
<b>D -4.0</b>	650'	(592')				
<b>D -3.0</b>	500'	(442')				
<b>D -2.8</b>	470'	(412')

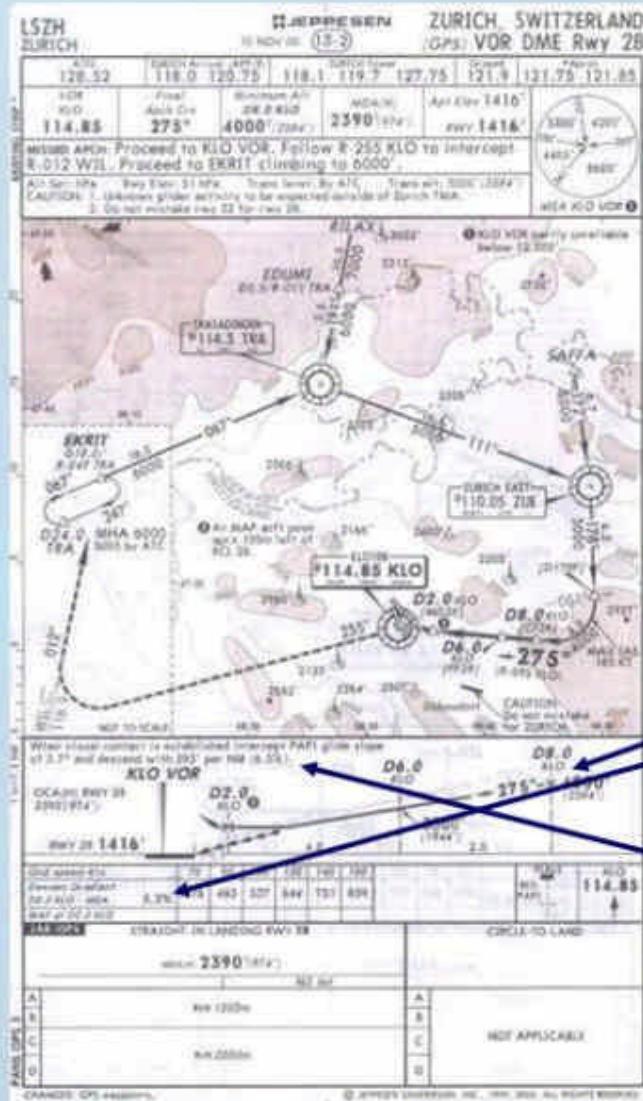
## VORDME Rwy 28 Chart in use

## Threats?

### No DME-Altitude Table.

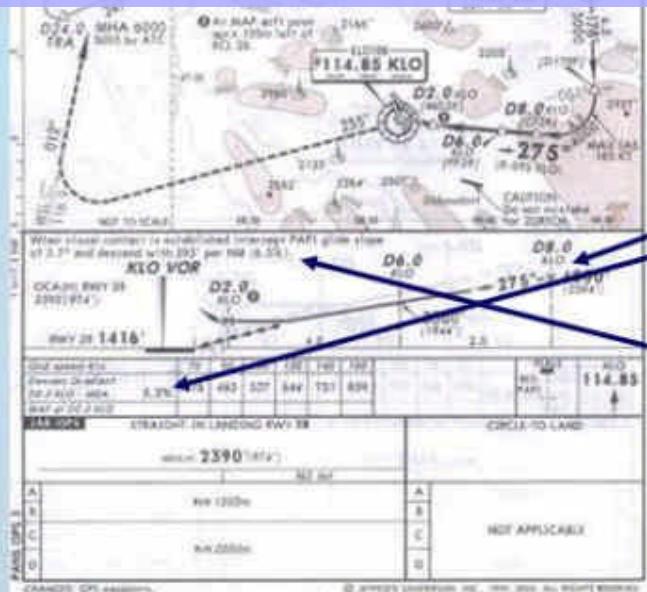
Start Approach  
at 8 DME - 4,000 ft

On 5.3% [3.0°] gradient to  
6 DME - 3,360 ft

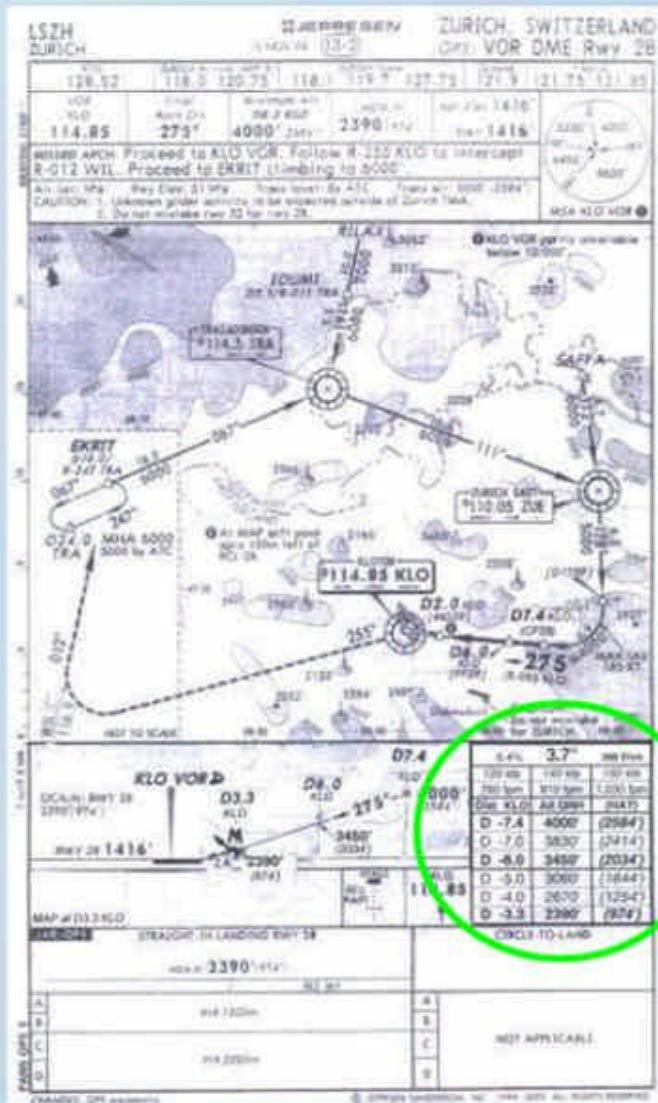
## Airbus chart with 3.7° DME-Altitude Table

**Threat Reduction :**  
Constant Angle NPAs are  
now recommended by ICAO.  
Should not also standardised  
DME-Altitude tables  
required to be shown on all charts?

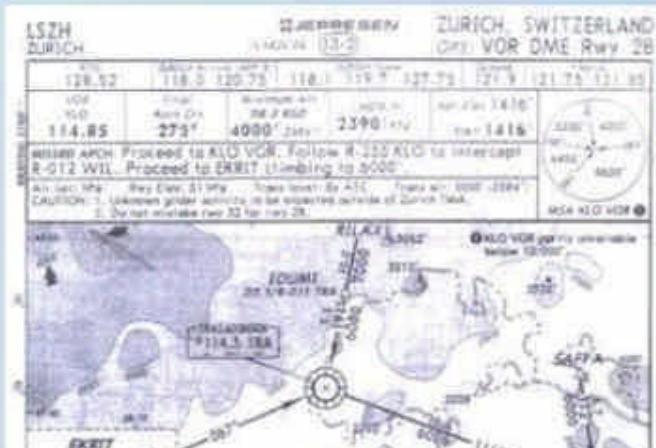
## Airbus chart with 3.7° DME-Altitude Table

Threat Reduction :  
Constant Angle NPAs are  
now recommended by ICAO.  
Should not also standardise  
DME-Altitude tables  
required to be shown on all charts?

Airbus FMGC Database contains ZRH 28

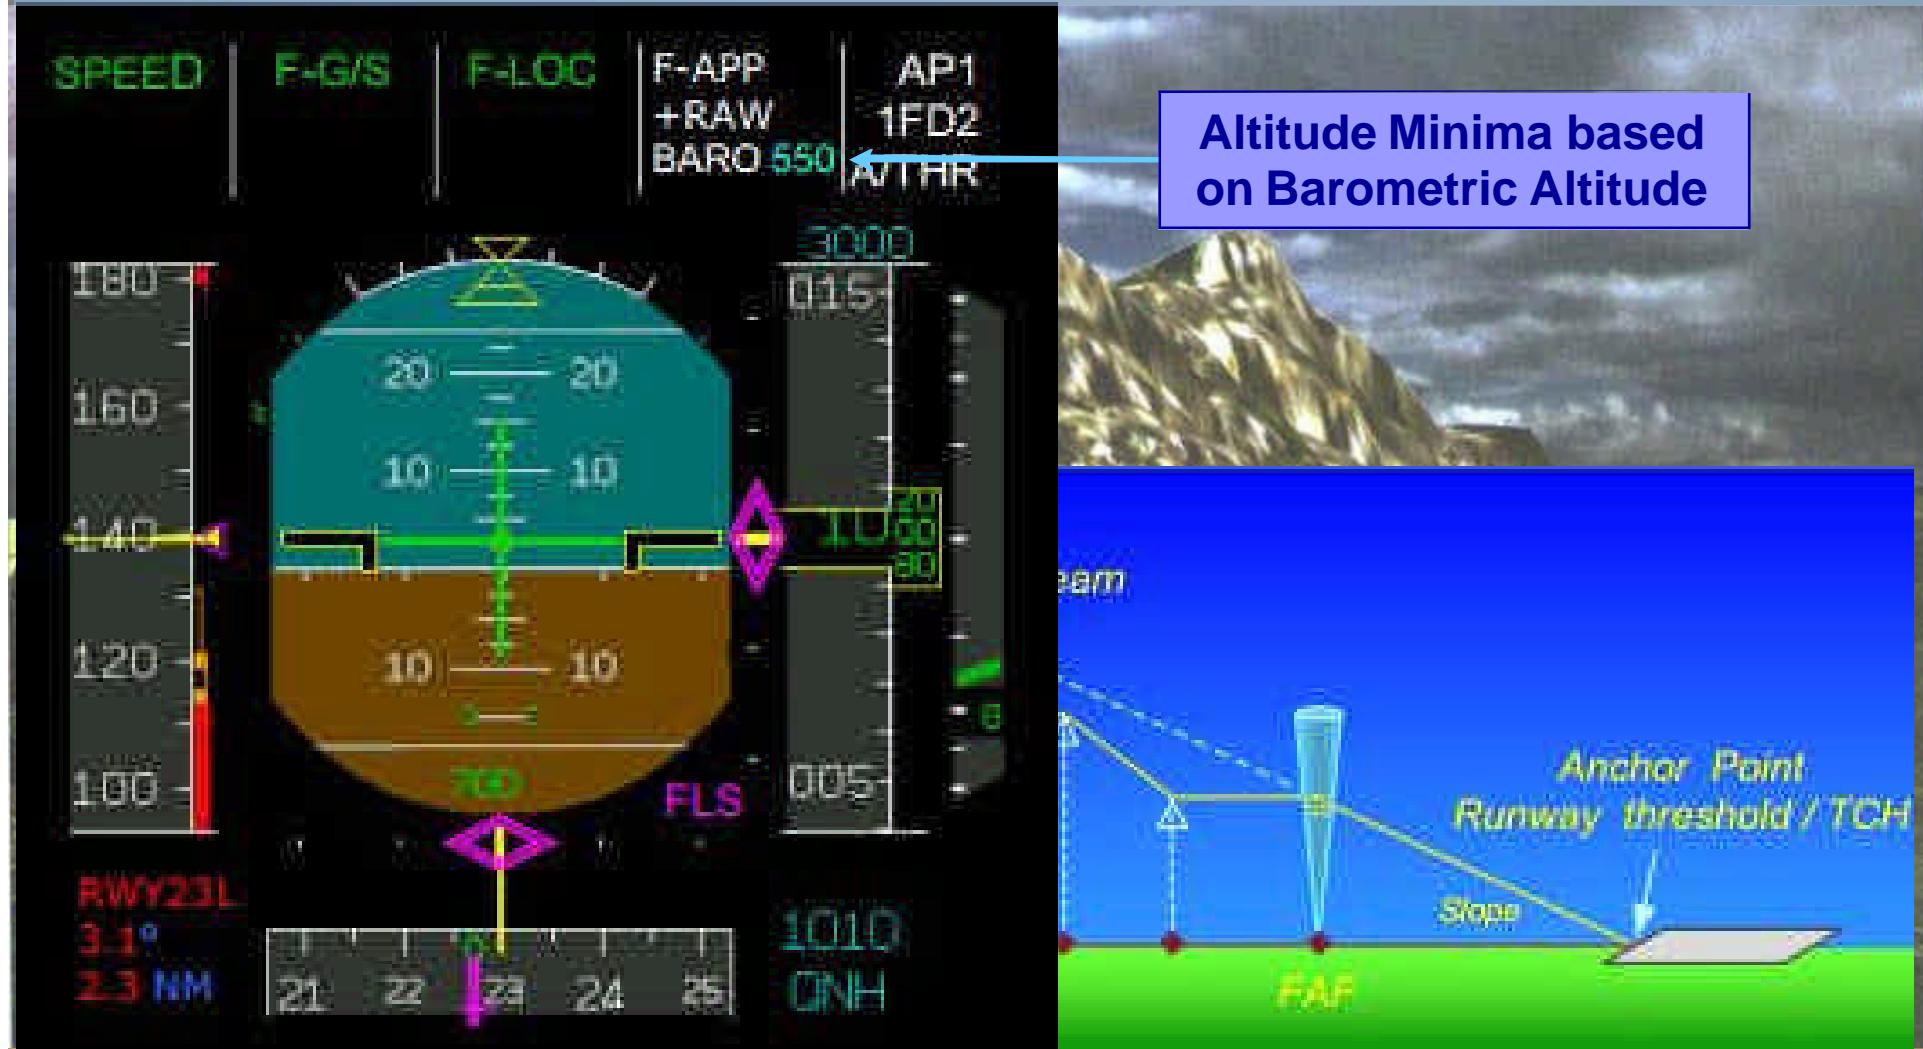
## Latest Airbus aircraft can fly FLS – ILS Look-alike (Fms generated Landing System)

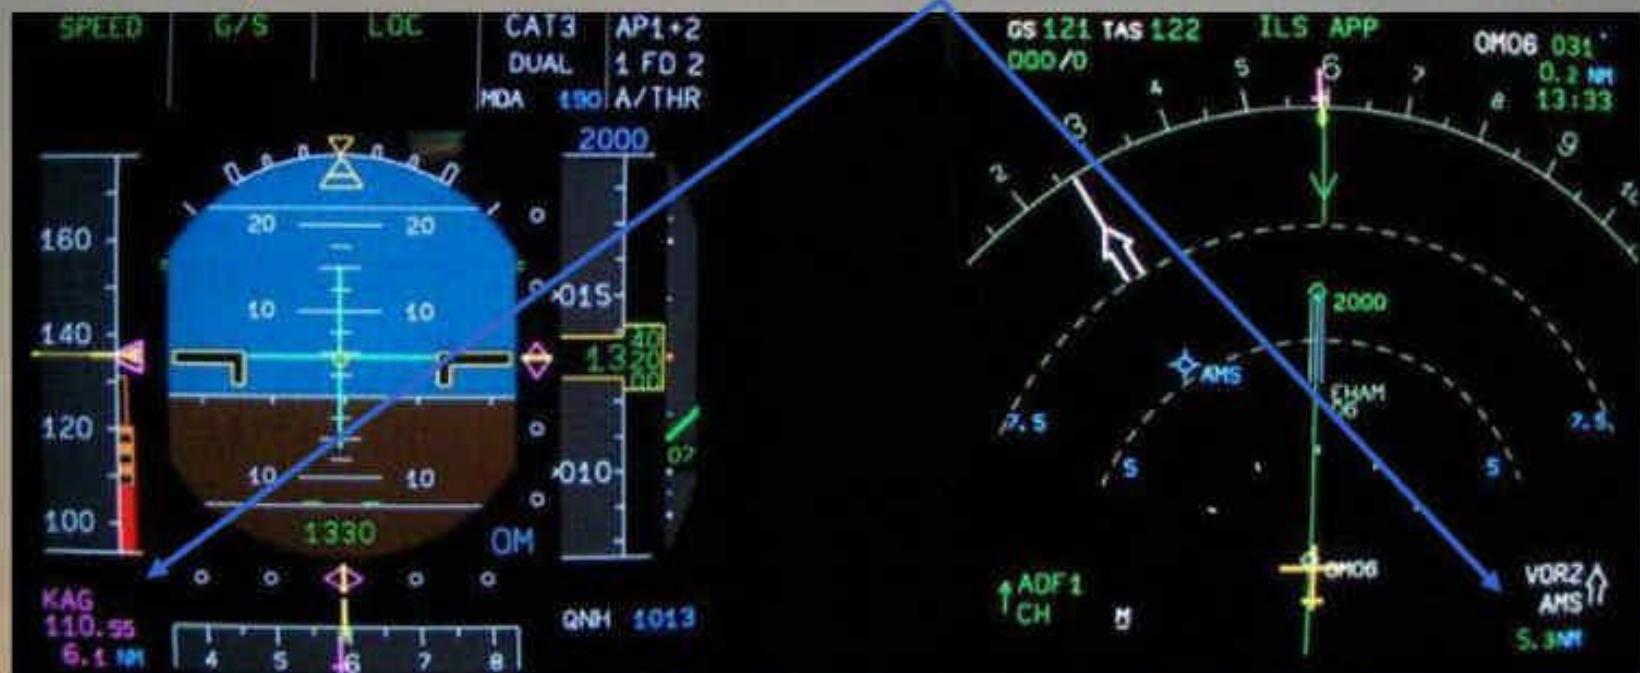
DME (Distance Measuring Equipment) reads to 0.1 n mile, therefore:  
Altitudes on a 3 degree glidepath can be checked / flown to within 30ft (300 x .1)  
(It is important to use the correct DME - ILS or VOR if both are available!)

A DME in line with a runway can show an accurate glidepath on a Non Precision Approach by a simple DME-Altitude table for a Constant Descent Angle approach. Many Step Down NPAs accidents could have been avoided over the past 30 years.

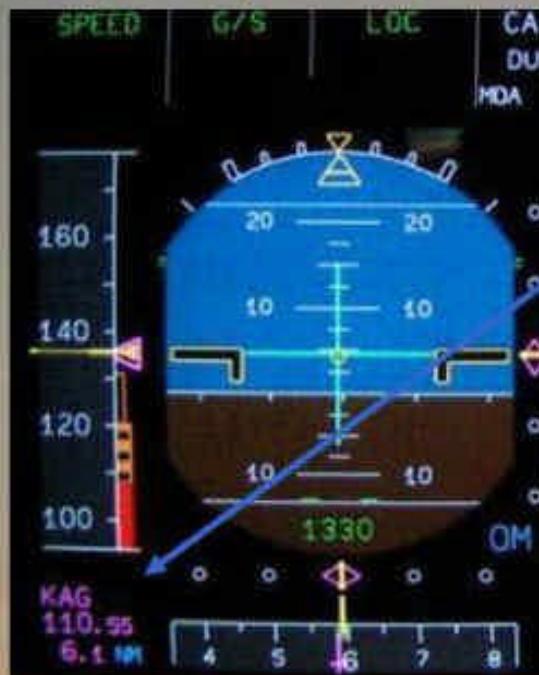
BHM LOC-DME 18

# **DME-Altitude Table for LOC-DME R/W 18 Birmingham Alabama**

**1 n mile**, therefore:  
to within 30ft ( $300 \times .1$ )  
both are available!

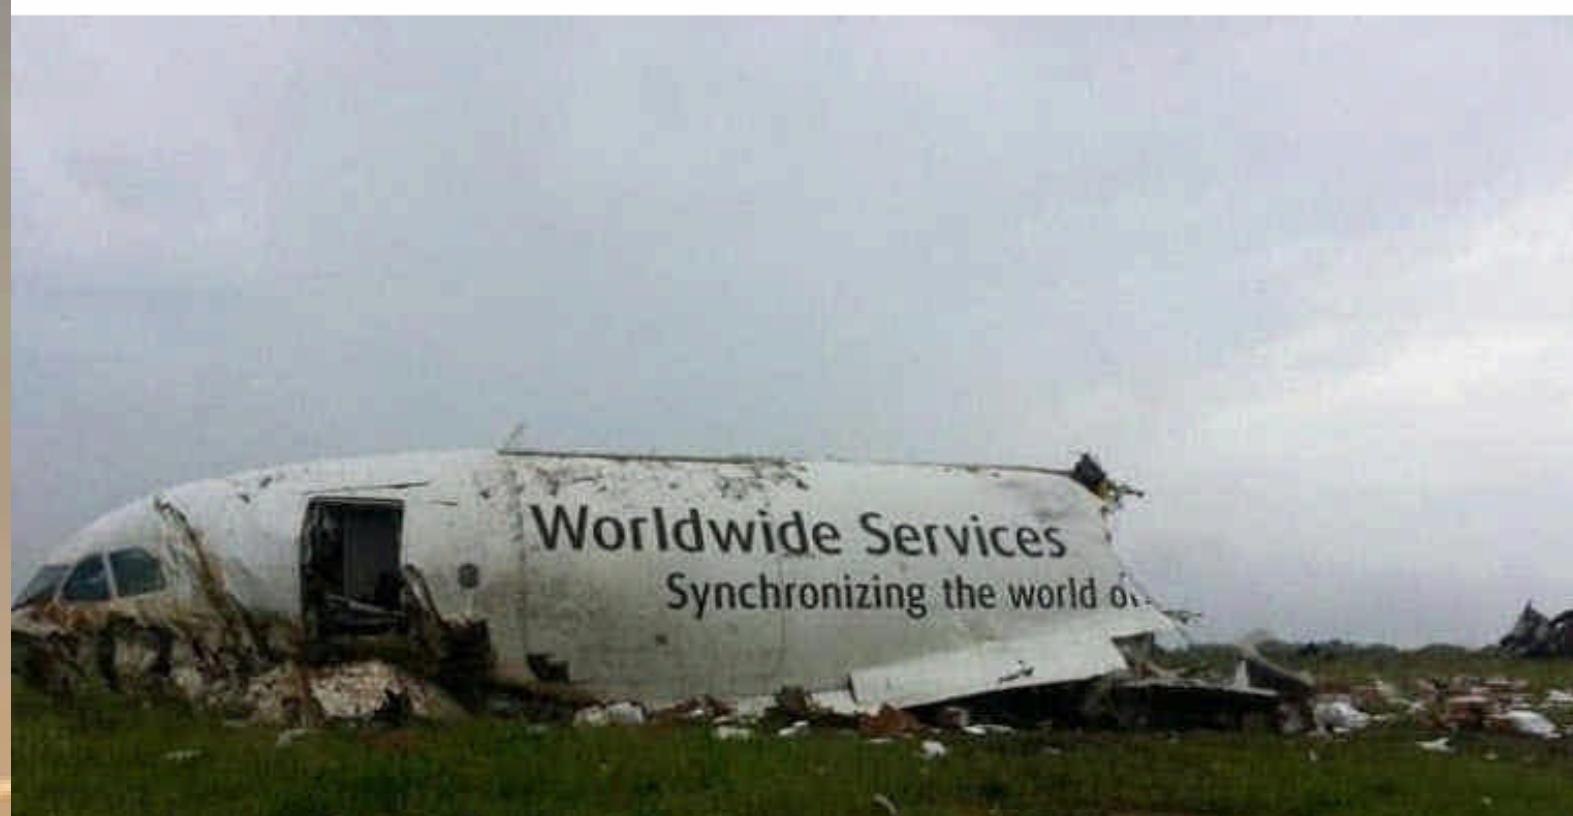
Crash UPS A306 at Birmingham on Aug 14th 2013, contacted trees and touched down outside airport

**On 14Aug 2013 UPS 5X-1354 Airbus A300-600F N155UP freighter crashed short of the runway on a LOC-DME approach to R/W 18 Birmingham AL.**

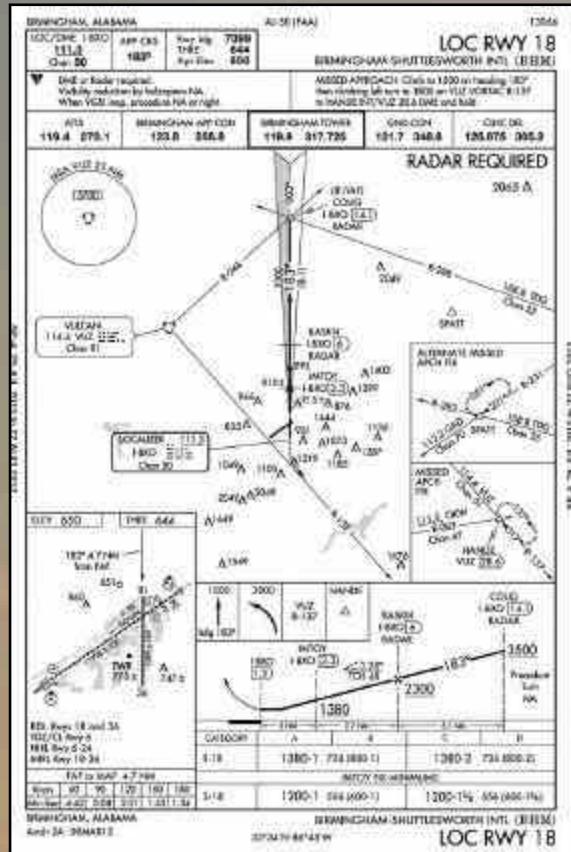
BHM LOC-DME 18		
Gradient:	3.2°	342 ft/nm
120 kts	140 kts	160 kts
680 fpm	800 fpm	910 fpm
D I-BX0	Alt QNH	(HAT)
D -14.1	5070'	(4426')
D -9.5	3500'	(2856')
D -8.0	2980'	(2336')
D -7.0	2640'	(1996')
D -6.0	2300'	(1656')
D -5.0	1960'	(1316')
D -4.0	1620'	(976')
D -3.3	1380'	(736')
D -2.0	930'	(286')

**The FAA LOC-DME chart does not include a DME-Altitude table, such as on the right showing that the straight line profile is not realistic.**

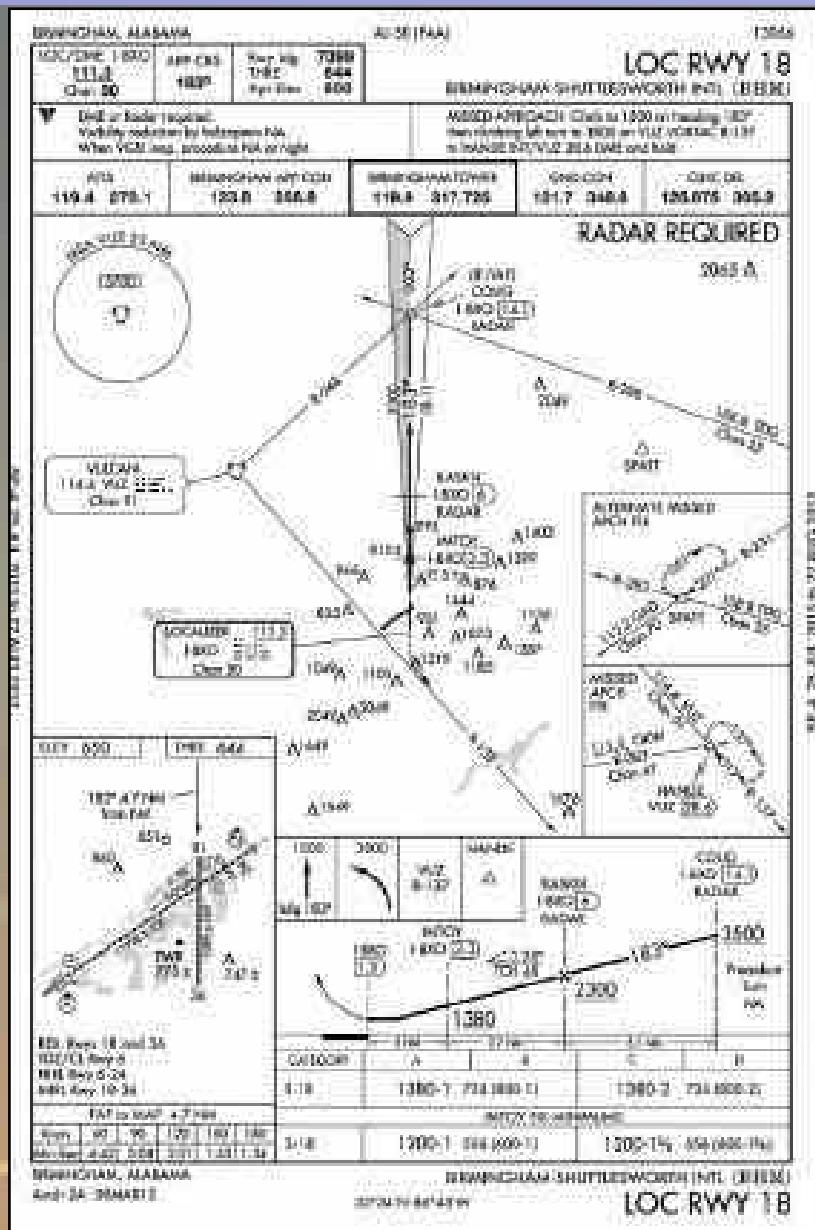
## FAA LOC-DME Chart without table & Possible Table

BHM LOC-DME 18		
Gradient:	3.2°	342 ft/nm
120 kts	140 kts	160 kts
680 fpm	800 fpm	910 fpm
D -18.0	Alt QNH	(HAT)
D -14.1	5070'	(4426')
D -9.5	3500'	(2856')
D -8.0	2980'	(2336')
D -7.0	2640'	(1996')
D -6.0	2300'	(1656')
D -5.0	1960'	(1316')
D -4.0	1620'	(976')
D -3.3	1380'	(736')
D -2.0	930'	(286')
