**“Reduce Continuing CFIT Accidents by  
Training Constant Descent Final Approaches  
Using Distance-Altitude Tables to Follow the  
Glideslope Angle to an Accuracy of 30ft”**

*Including LOC-DME Accident 14 Aug 13  
of UPS A300-600F into Birmingham, Alabama*

**Hugh DIBLEY** FRAeS, FRIN, CMILT

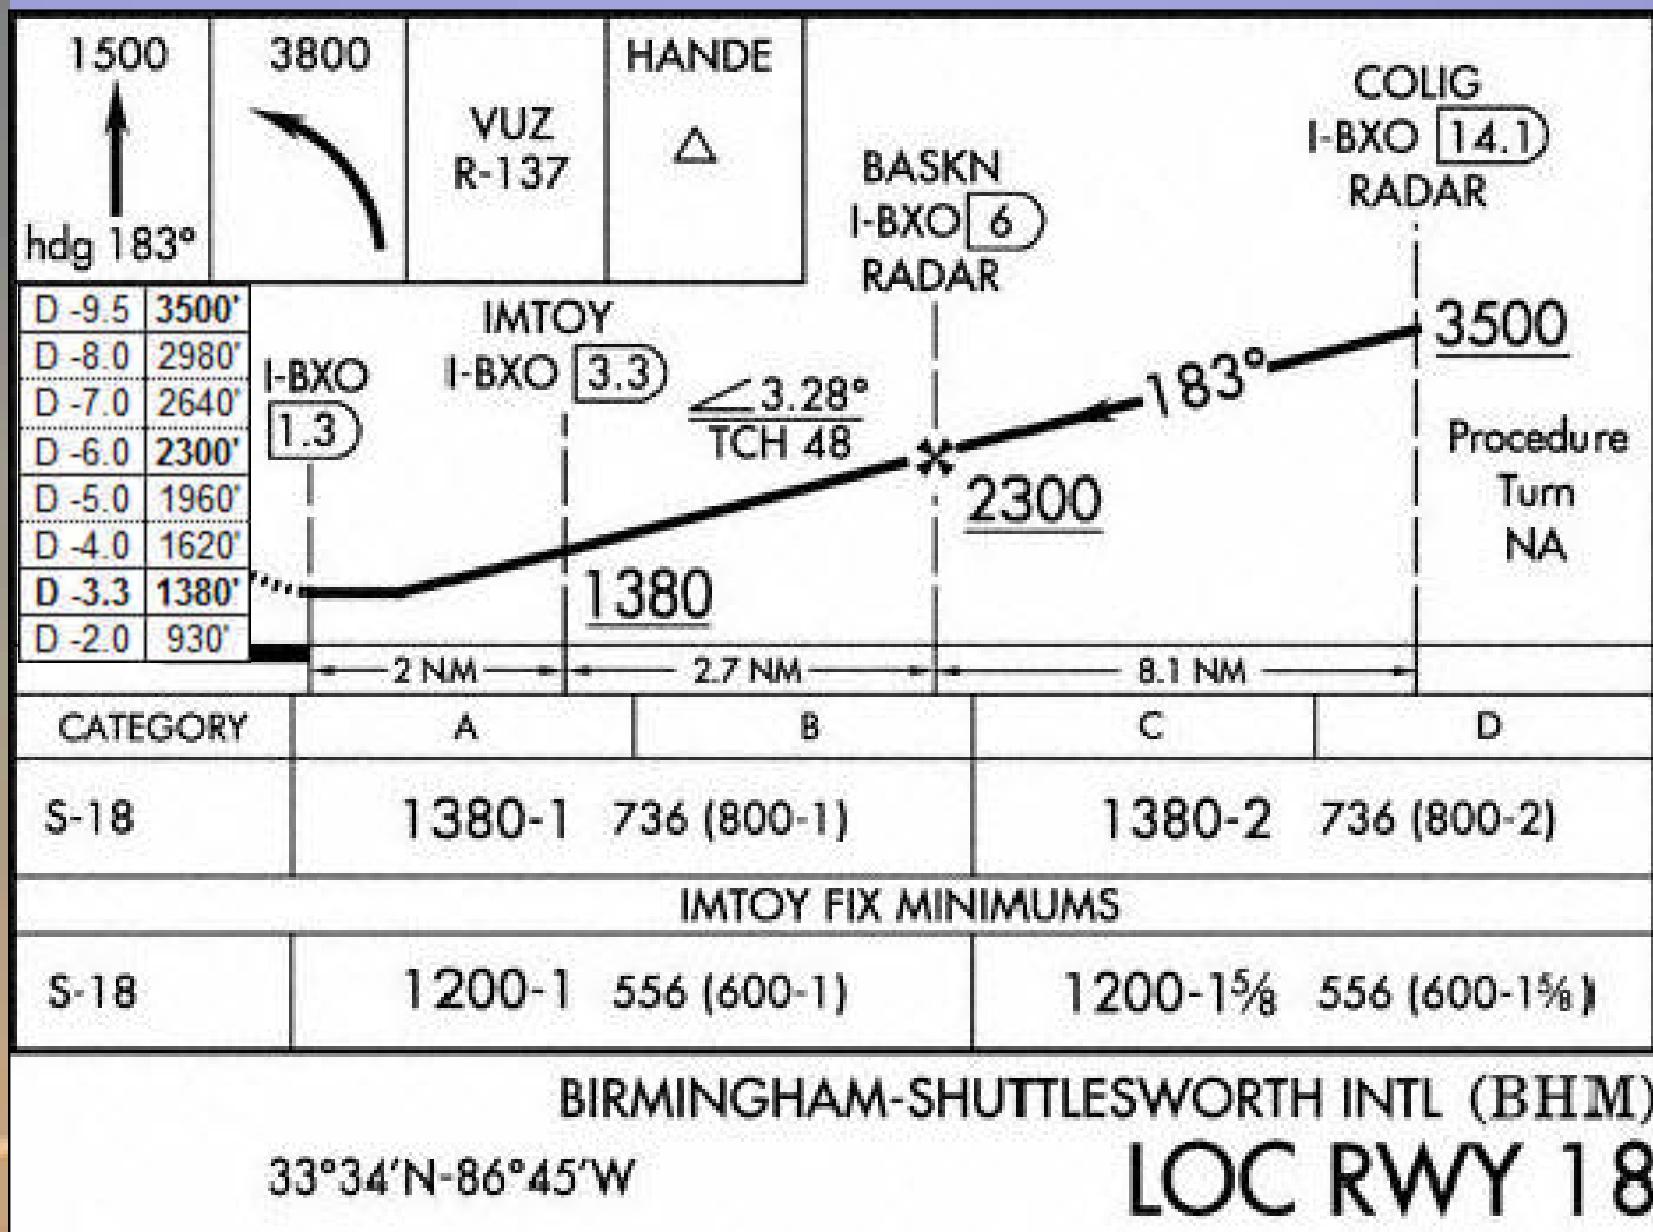
# BHM LOC-DME Chart – Unrealistic Published Profile

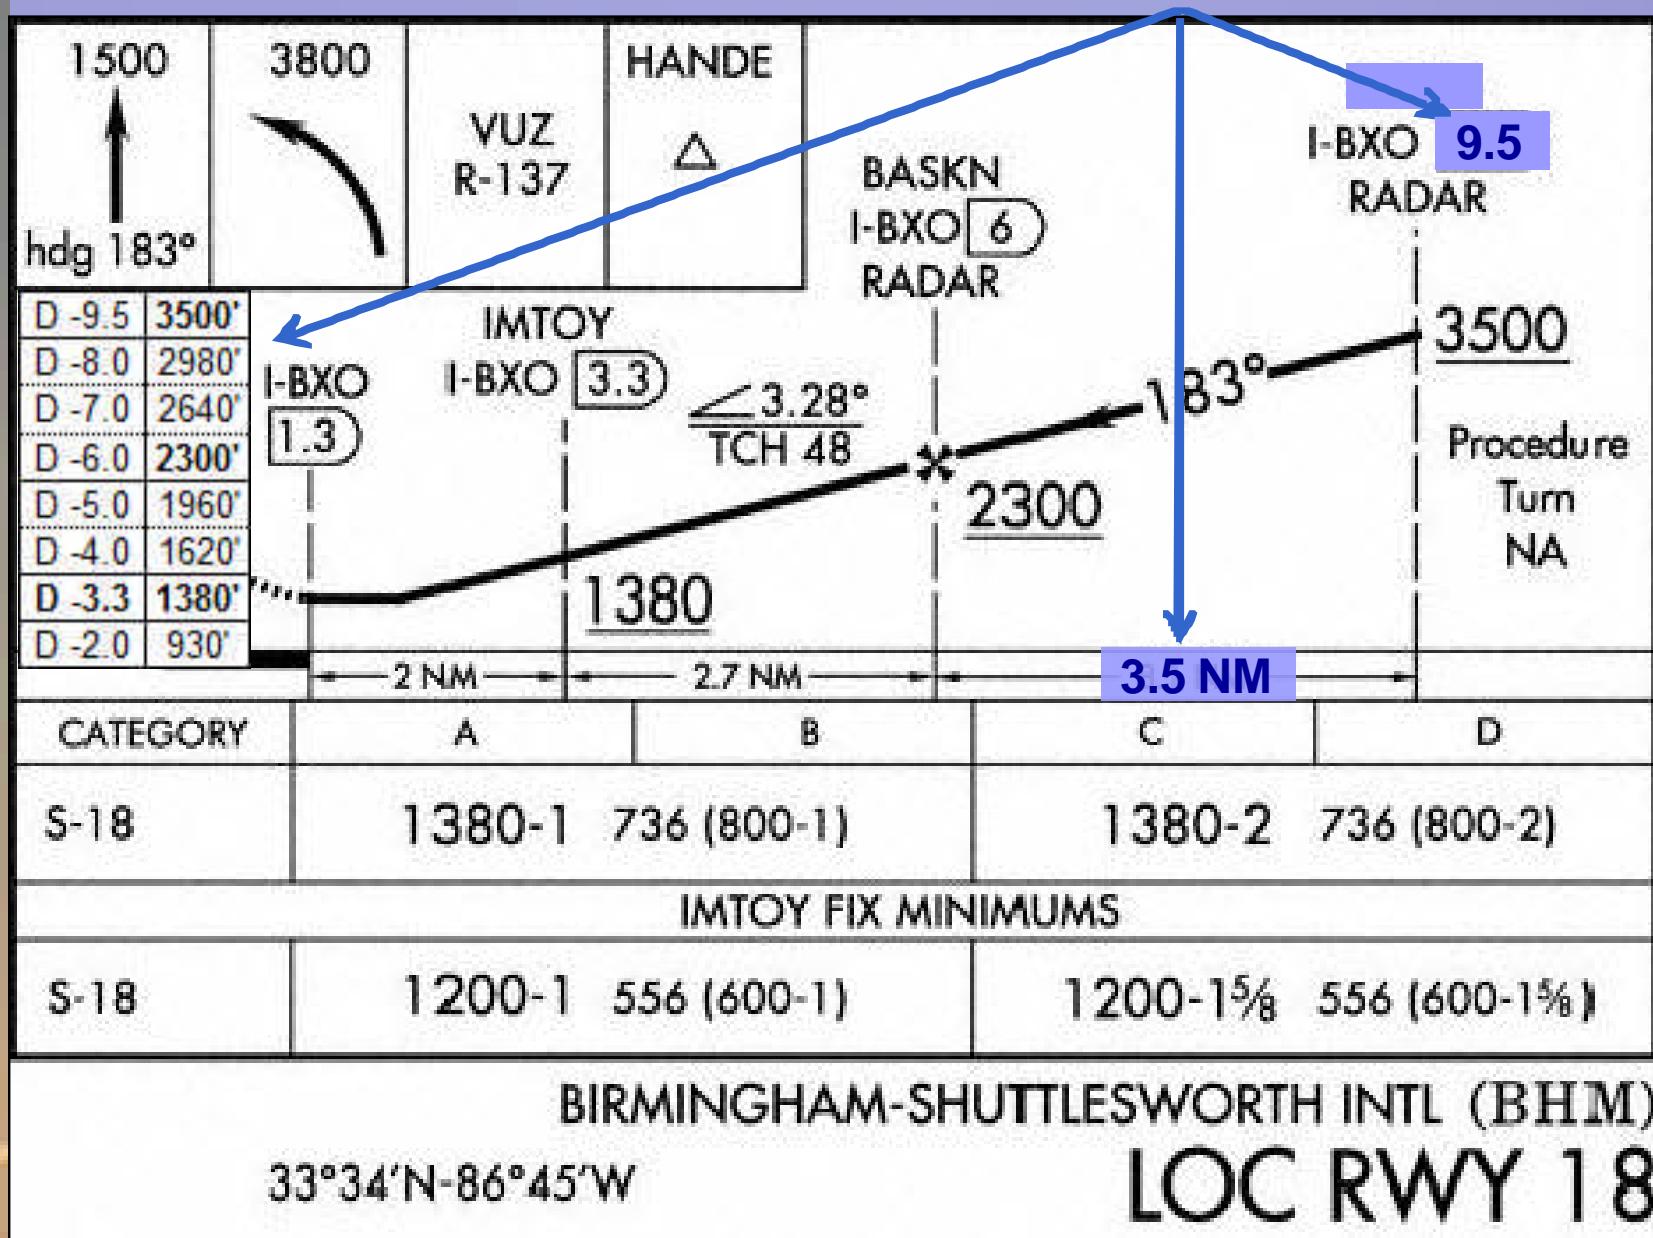
## BHM LOC-DME Chart - *Correct Distances for Profile*

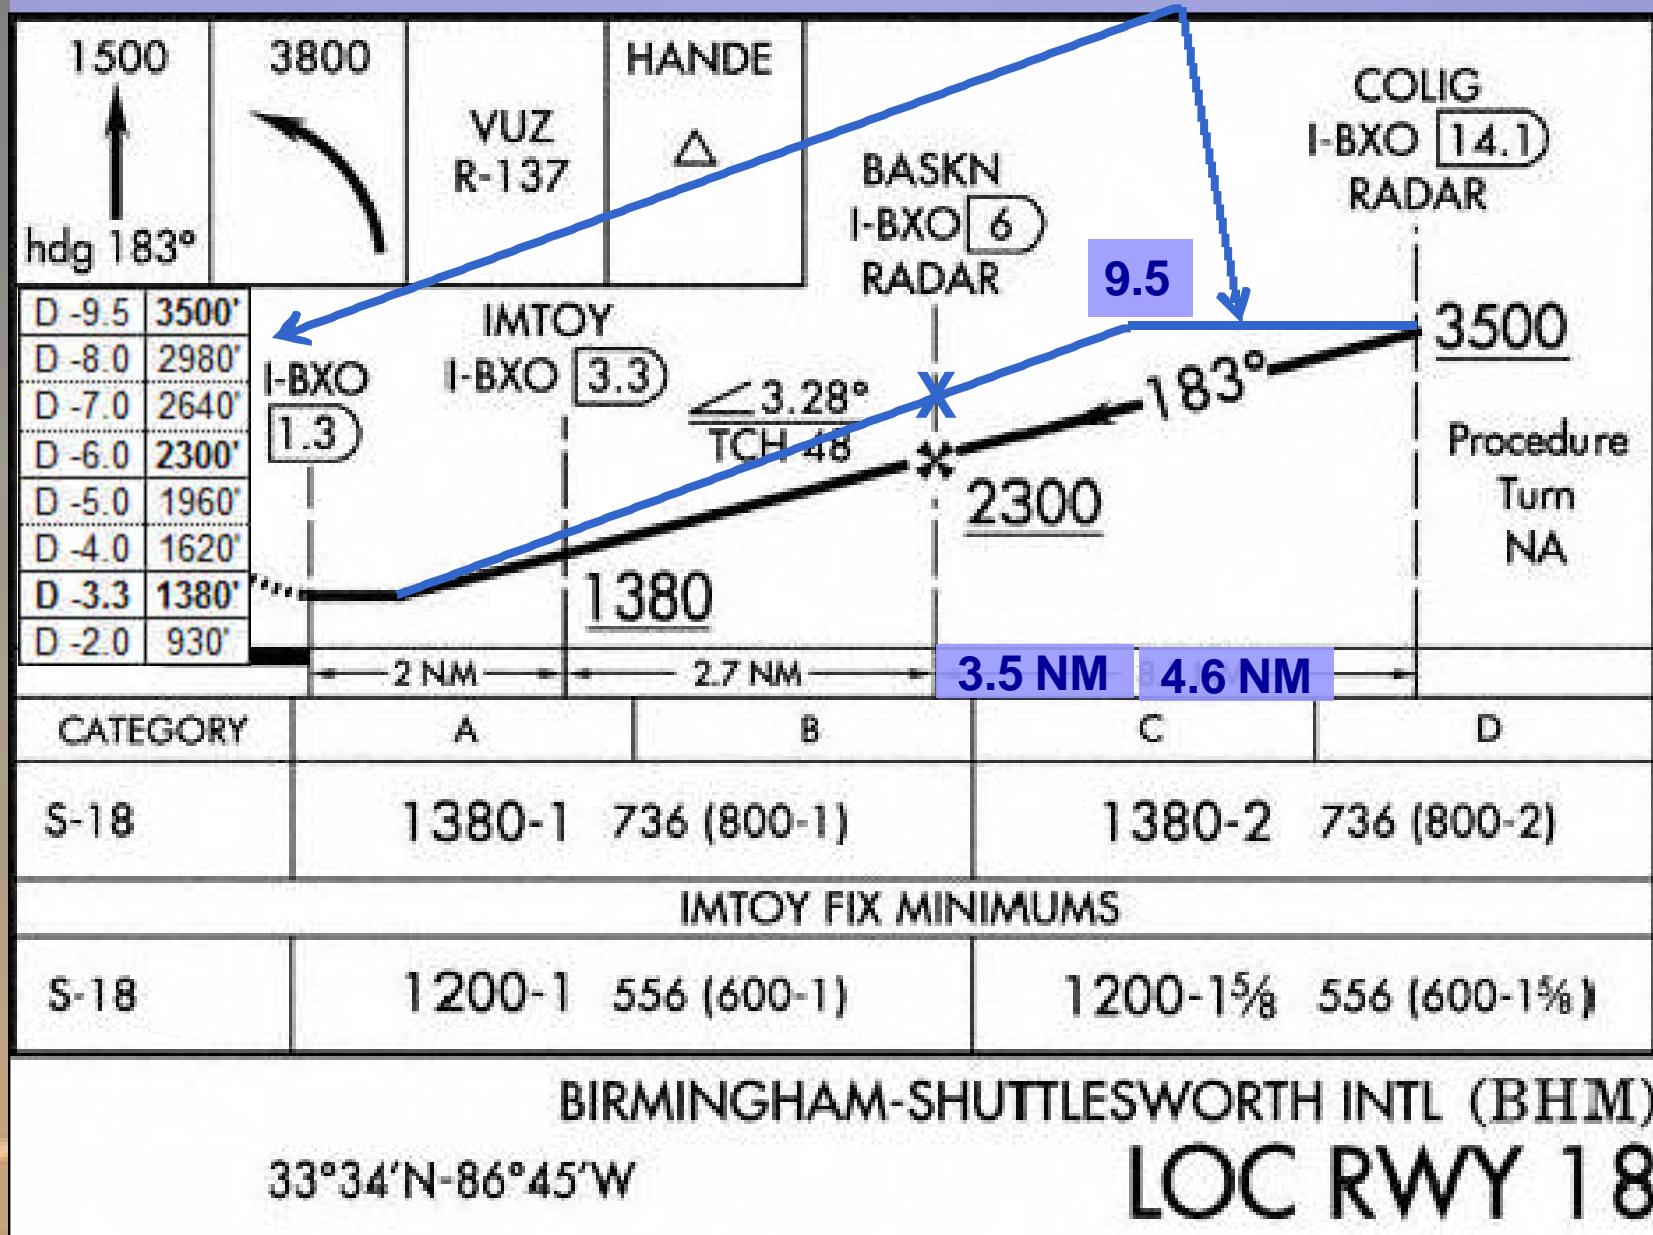
# BHM LOC-DME Chart *Correct Profile for Distances 1*

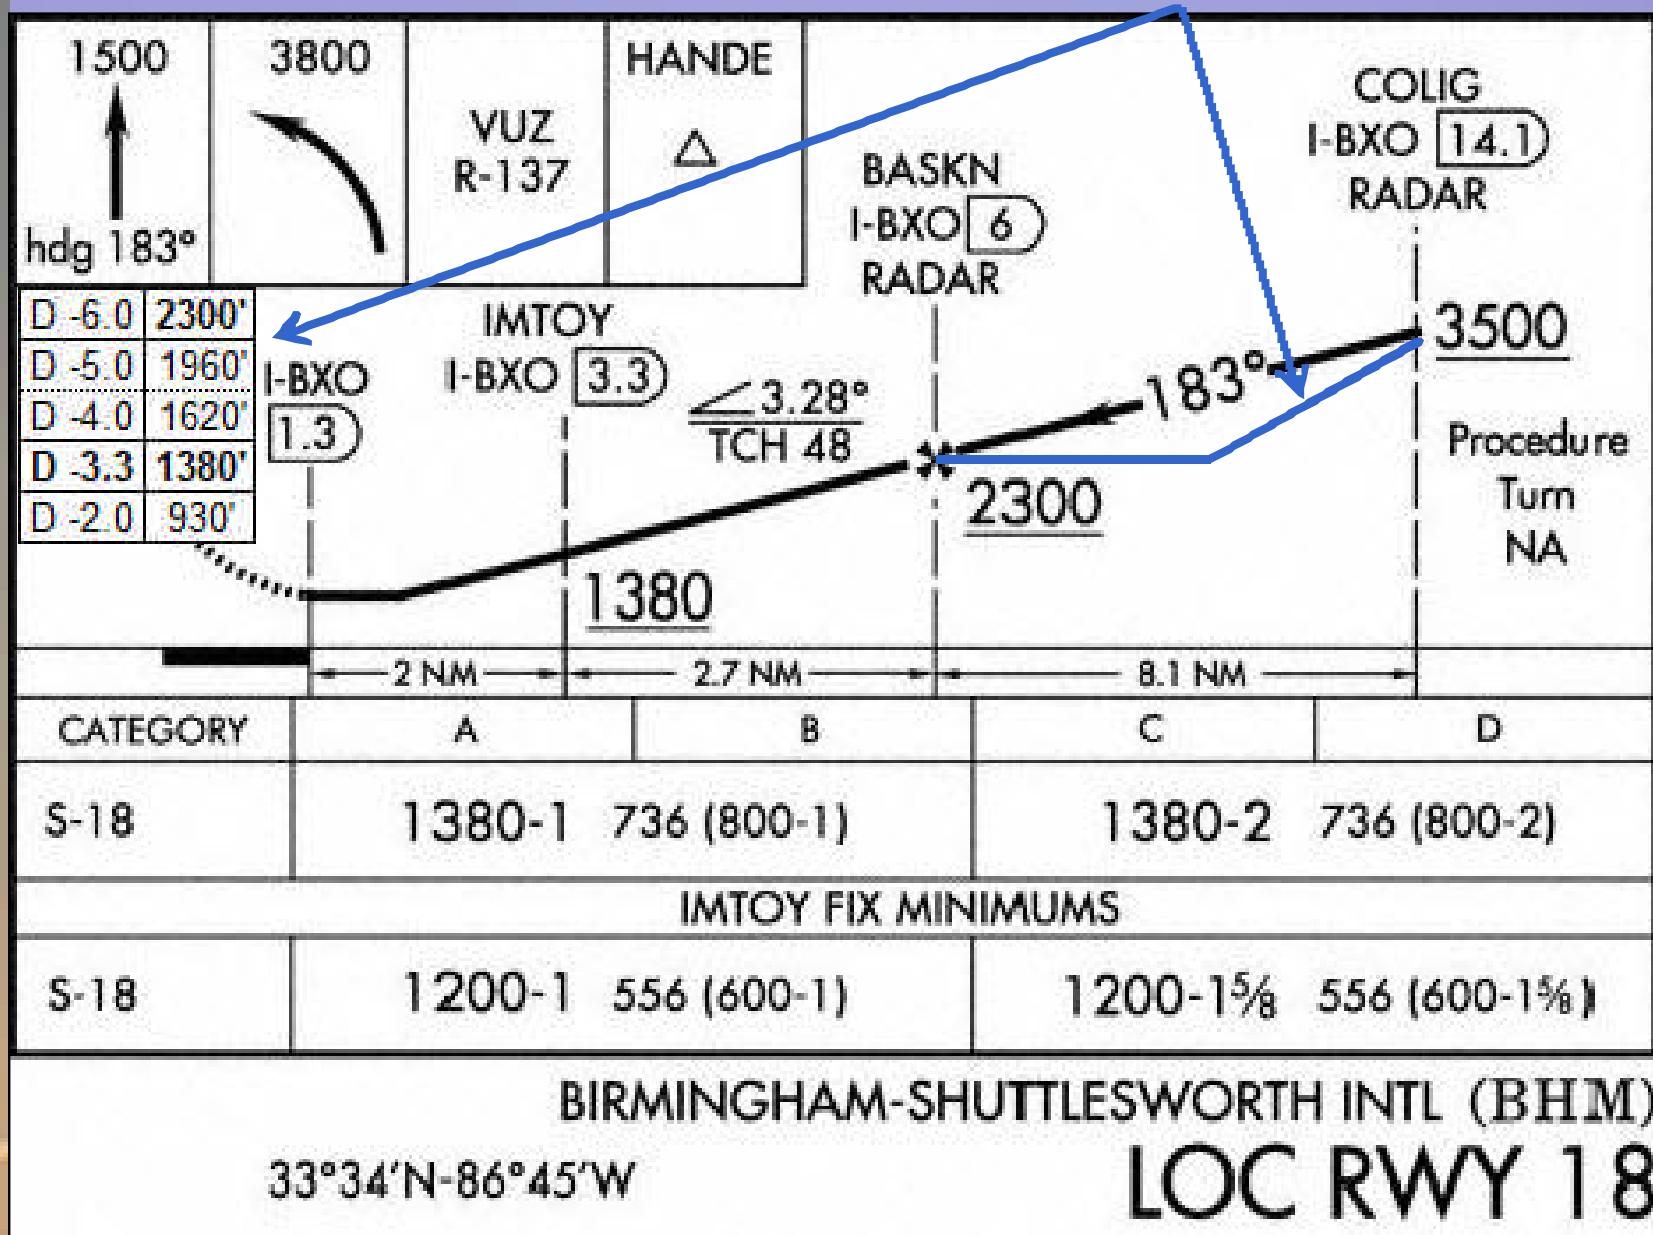
## BHM LOC-DME Chart *Correct Profile for Distances 2*

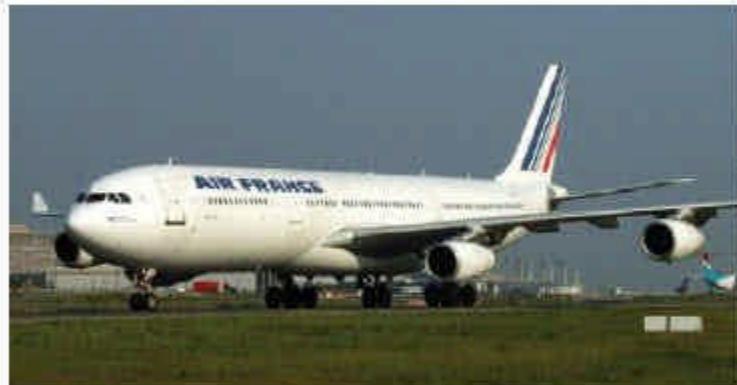
Inquiries found the Airbus was flying far above the true glidepath

2,100ft too high. Such was the height discrepancy the aircraft became vulnerable to a false glideslope. The phenomenon is caused by mirroring of the ILS antenna transmissions, and creates the illusion of a second glideslope located above – and therefore steeper than – the true one.

# 1 March 2012 A340 Captured False 9° Glideslope

Investigators are attributing the serious incident – which took place on 13 March 2012 – to inadequate monitoring of the A340's trajectory by both crew and controller, the pilots' use of an "inappropriate" technique to capture the glideslope from above, and possible fatigue. ■
